## South East New Territories (SENT) Landfill Extension

Monthly Environmental Monitoring & Audit Report No.5  
for May 2019

## Monthly Environmental Monitoring & Audit Report for May 2019

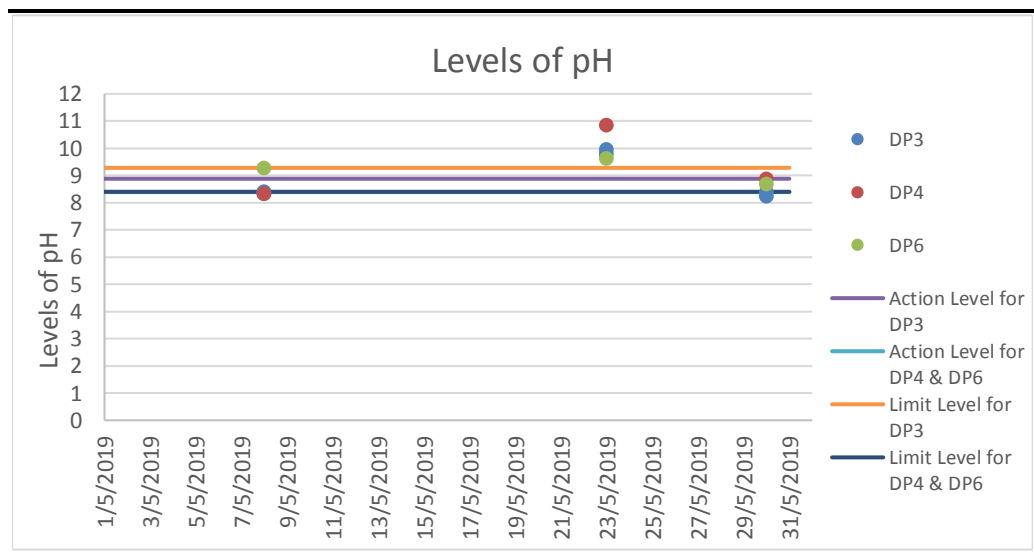
**Figure F2.2 Graphical Presentation for Surface Water Quality Monitoring (pH)**

6 Limit Level of pH exceedances and 6 Limit Level of Suspended Solids (SS) exceedances were recorded for surface water quality impact monitoring in the reporting period. The pH and SS exceedances at DP6 on 8 May 2019, pH and SS exceedances at DP3 and pH exceedance at DP6 on 23 May 2019 were considered not Project-related upon further investigation. The pH and SS exceedances at DP4 (Future, temporary) and SS exceedance at DP6 on 23 May 2019 were found deemed to Project-related activities. The pH and SS exceedances at DP4 (Future, temporary) and DP6 on 30 May 2019 are under investigation.
