## South East New Territories (SENT) Landfill Extension

Monthly Environmental Monitoring & Audit Report No.28  
for April 2021

## Monthly Environmental Monitoring & Audit Report for April 2021

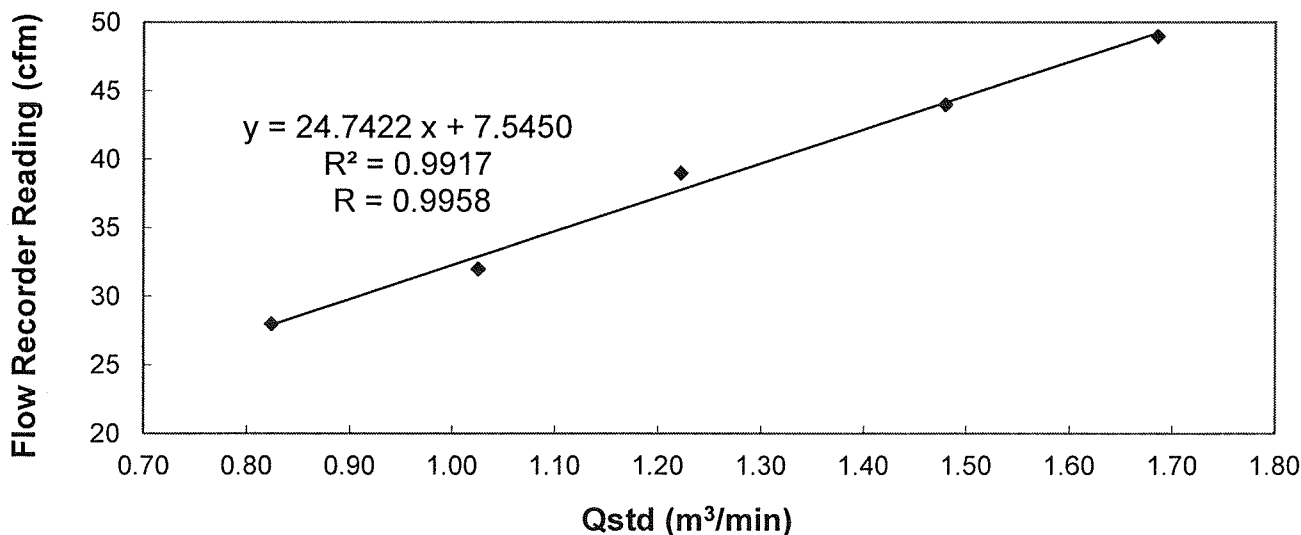
Results	Flow recorder reading (cfm)	49	44	39	32	28
	Qstd (Actual flow rate, m <sup>3</sup> /min)	1.69	1.48	1.22	1.03	0.82
	Pressure : 762.06 mm Hg	Temp. : 298 K

**Sampler 9795 Calibration Curve**  
**Site: Tseung Kwan O 137 (TKO-A1)**

Acceptance Criteria : Correlation coefficient (r) of the calibration curve greater than 0.990 after a 5-point calibration

The high volume sampler complies\* / ~~does not comply\*~~ with the specified requirements and is deemed acceptable\* / ~~unacceptable\*~~ for use.

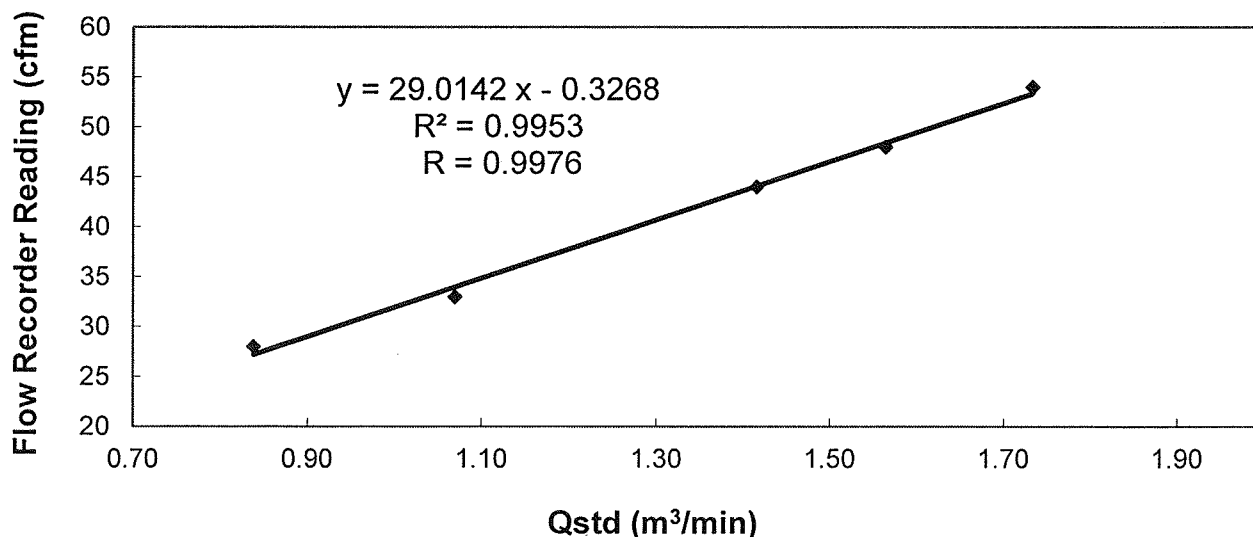
Flow recorder reading (cfm)	54	48	44	33	28
Qstd (Actual flow rate, m <sup>3</sup> /min)	1.73	1.56	1.42	1.07	0.84
Pressure :	762.06 mm Hg			Temp. :	298 K

**Sampler 1176 Calibration Curve**  
**Site: Tseung Kwan O 137 (TKO-A2a)**

Acceptance Criteria : Correlation coefficient (r) of the calibration curve greater than 0.990 after a 5-point calibration

The high volume sampler complies\* / ~~does not comply\*~~ with the specified requirements and is deemed acceptable\* / unacceptable\* for use.

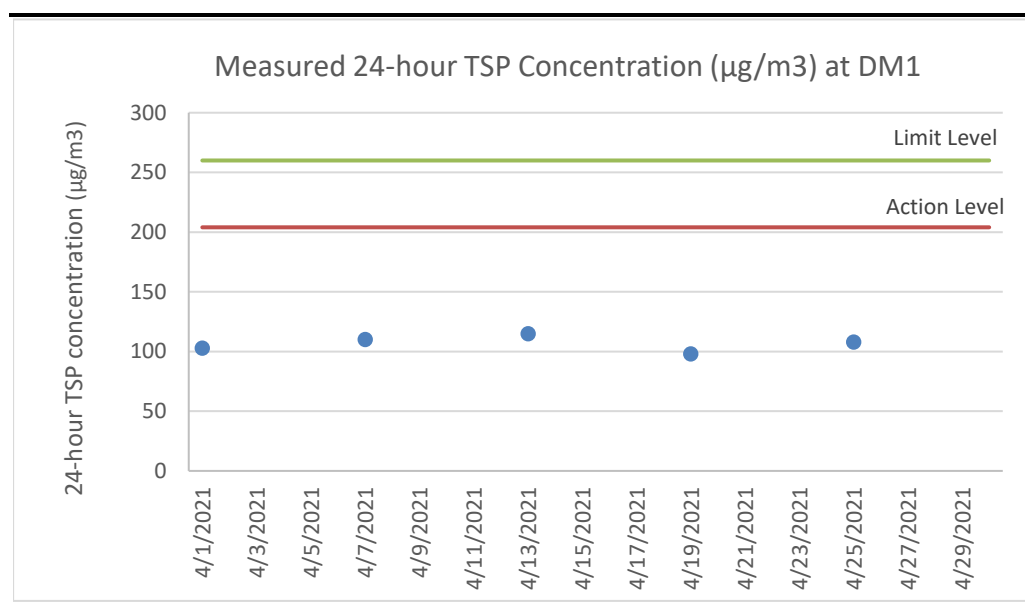
**Note:**  
DM1 corresponds to the existing TSP monitoring station TKO-A1 currently operating by CEDD.

**Figure D2.1 Graphical Presentation for 24-hr TSP Monitoring at DM1**

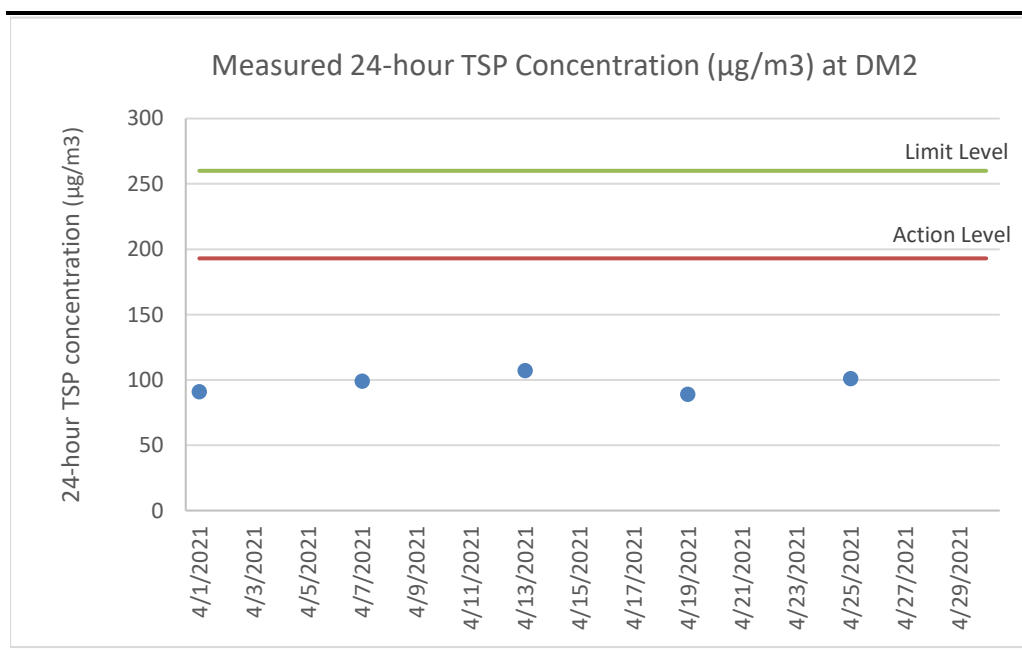
DM2 corresponds to the existing TSP monitoring station TKO-A2a currently operating by CEDD.

**Figure D2.2 Graphical Presentation for 24-hr TSP Monitoring at DM2**

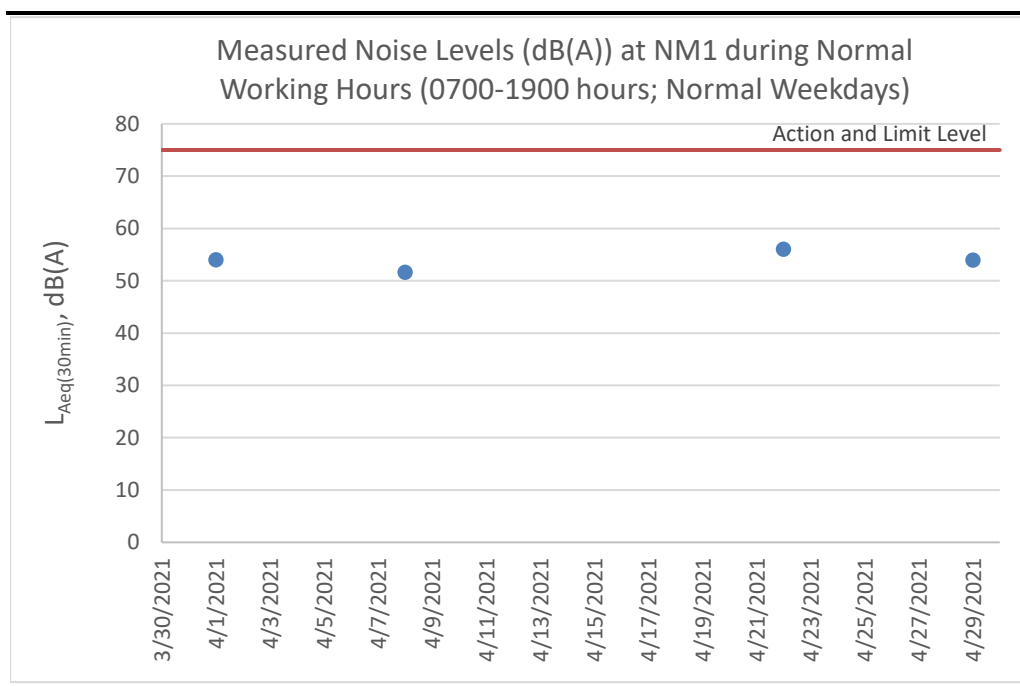
Correction of +3 dB(A) was made for free field measurements.

**Figure E2.1 Graphical Presentation for Noise Monitoring at NM1**
