## South East New Territories (SENT) Landfill Extension

Monthly Environmental Monitoring & Audit Report No.31  
for July 2021

## Monthly Environmental Monitoring & Audit Report for July 2021

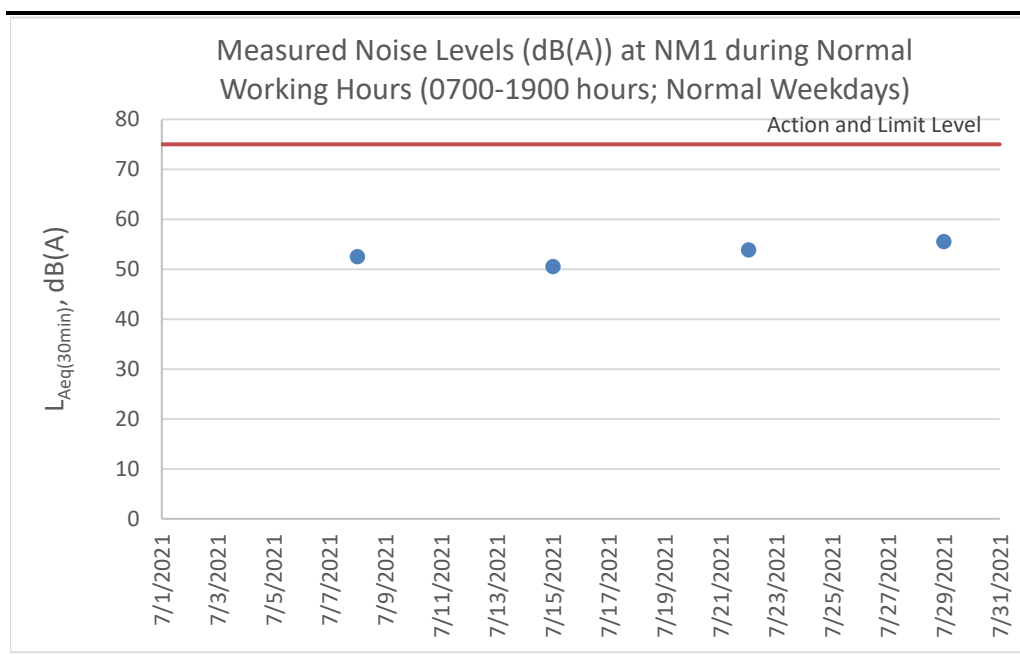
Correction of +3 dB(A) was made for free field measurements.

**Figure E2.1 Graphical Presentation for Noise Monitoring at NM1**
