## South East New Territories (SENT) Landfill Extension

### Quarterly Environmental Monitoring & Audit Report No.2

August 2019

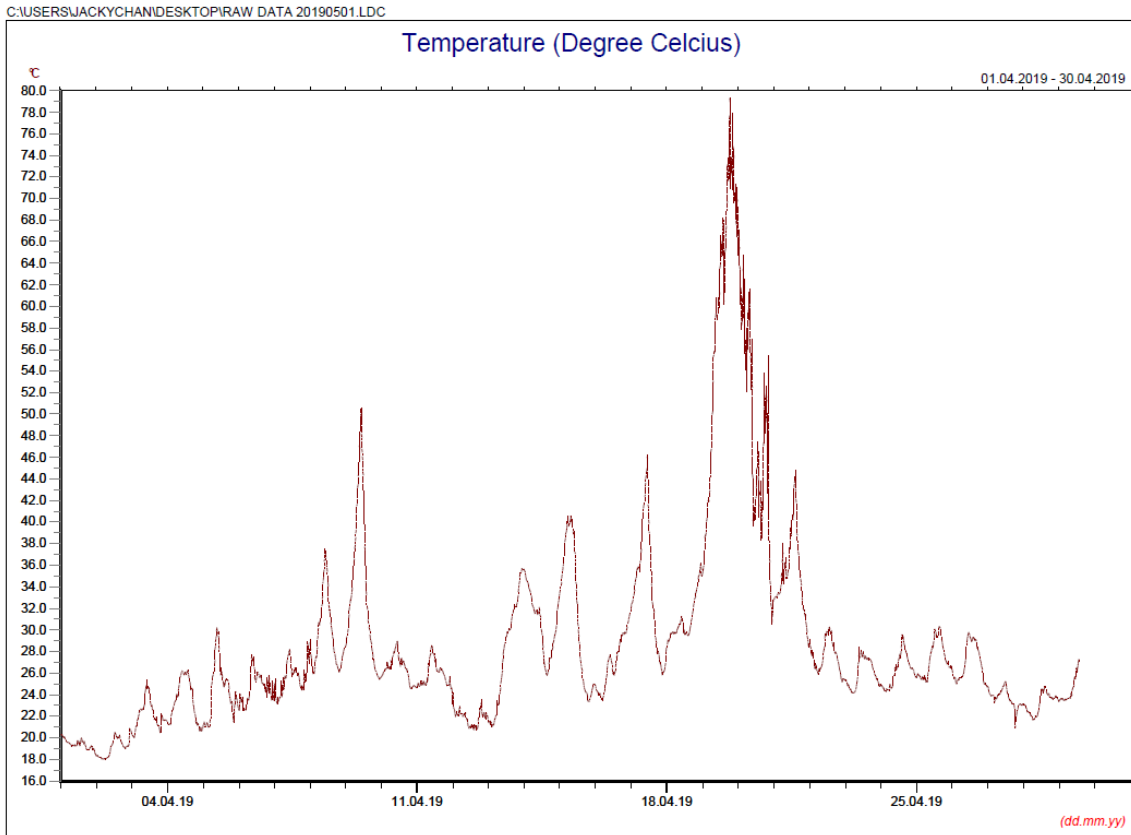
\* Note: Data on 20 April 2019 was discarded due to equipment failure.
