South East New Territories (SENT) Landfill Extension

Annual Environmental Monitoring & Audit Review Report No.1

January 2020

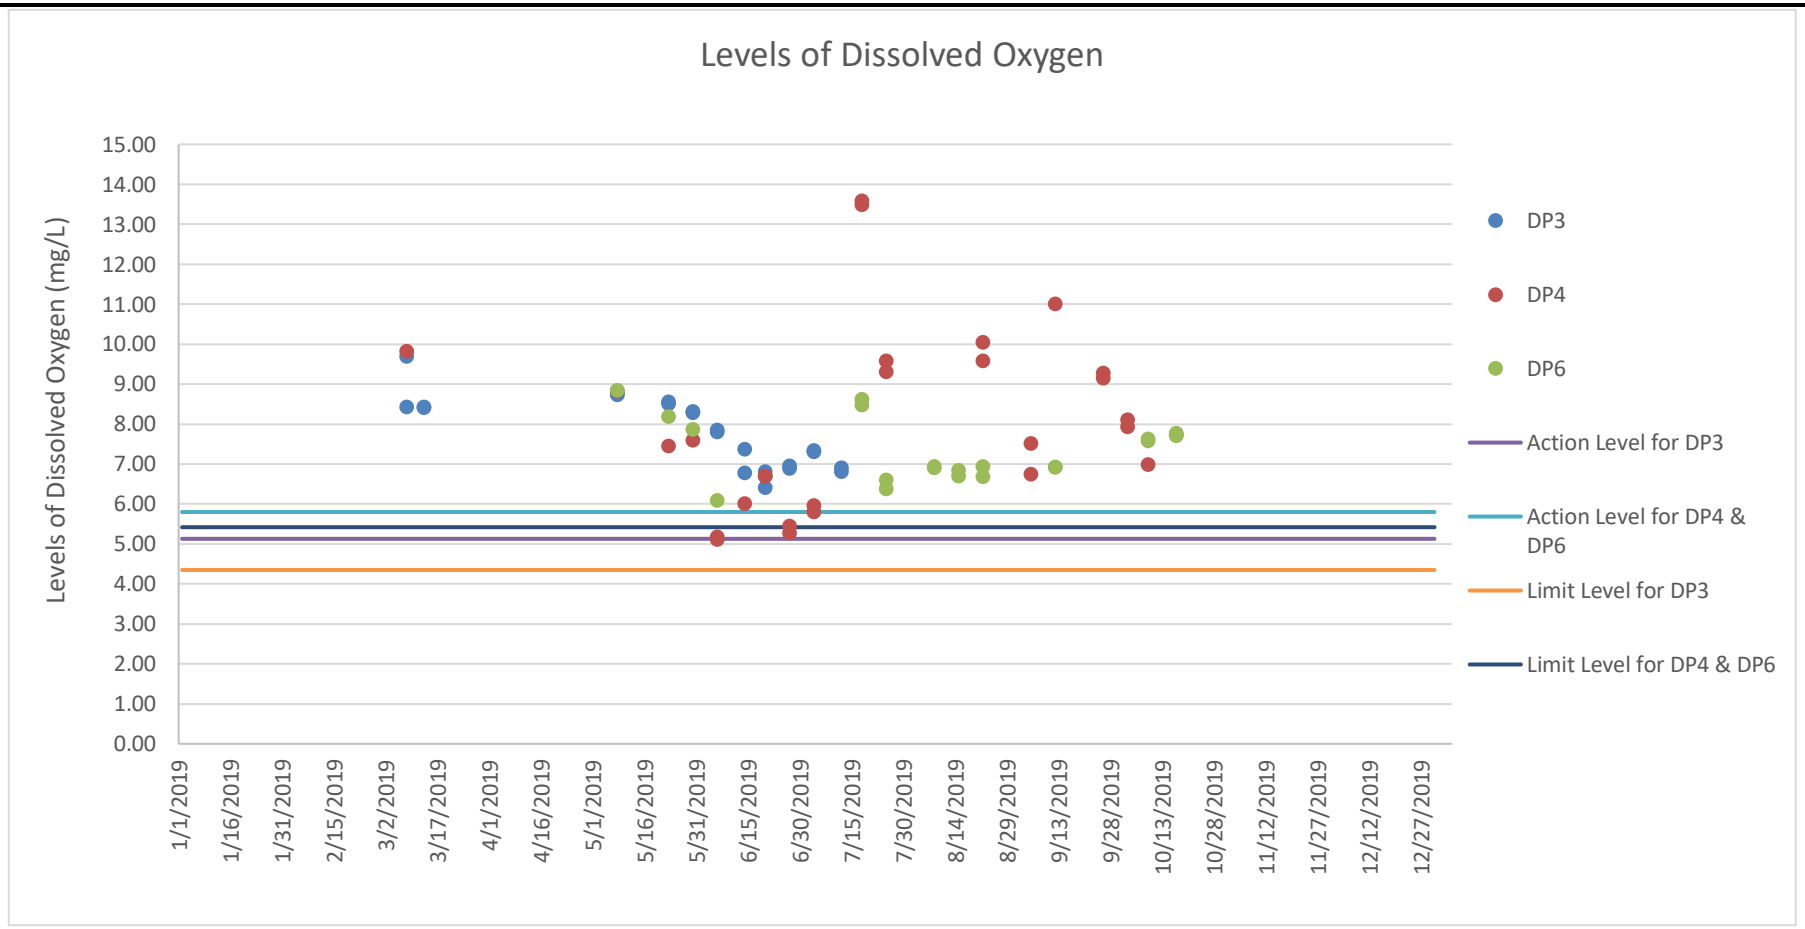
Figure F1.1 Graphical Presentation for Surface Water Quality Monitoring (DO)

2 exceedances of the Limit Level for DO, 15 exceedances of the Limit Level for pH and 19 exceedances of the Limit Level for Suspended Solids (SS) were recorded for surface water quality impact monitoring in the reporting period. The exceedances were considered non Project-related upon further investigations, except the pH and SS exceedances at DP4 (Future, temporary) and SS exceedance at DP6 on 23 May 2019 and SS exceedance at DP4 (Future, temporary) on 25 July 2019 which were found deemed to Project-related activities.
