South East New Territories (SENT) Landfill Extension

Monthly Environmental Monitoring & Audit Report No.44

for August 2022

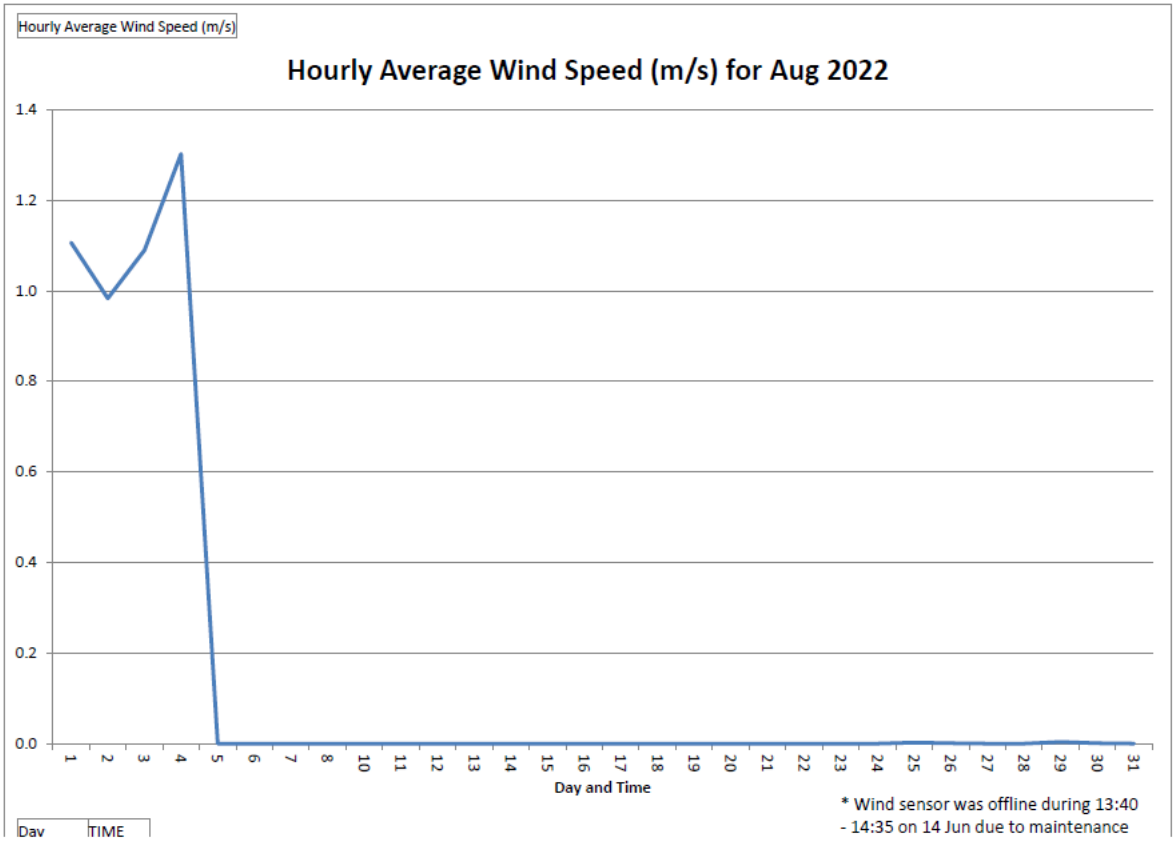
*Remark: Due to the Wind Speed Sensor has been disconnected on 4 Aug 2022, data loss in Aug 2022.
Due to the met station system failure on 8 Aug 2022, the data from 8 Aug 2022 - 09:20 to 10 Aug 2022 - 17:00 has been lost.
- Data from 5 Aug 2022 to 31 Aug 2022 is pending from Hong Kong Observatory and to be supplemented in subsequent version.

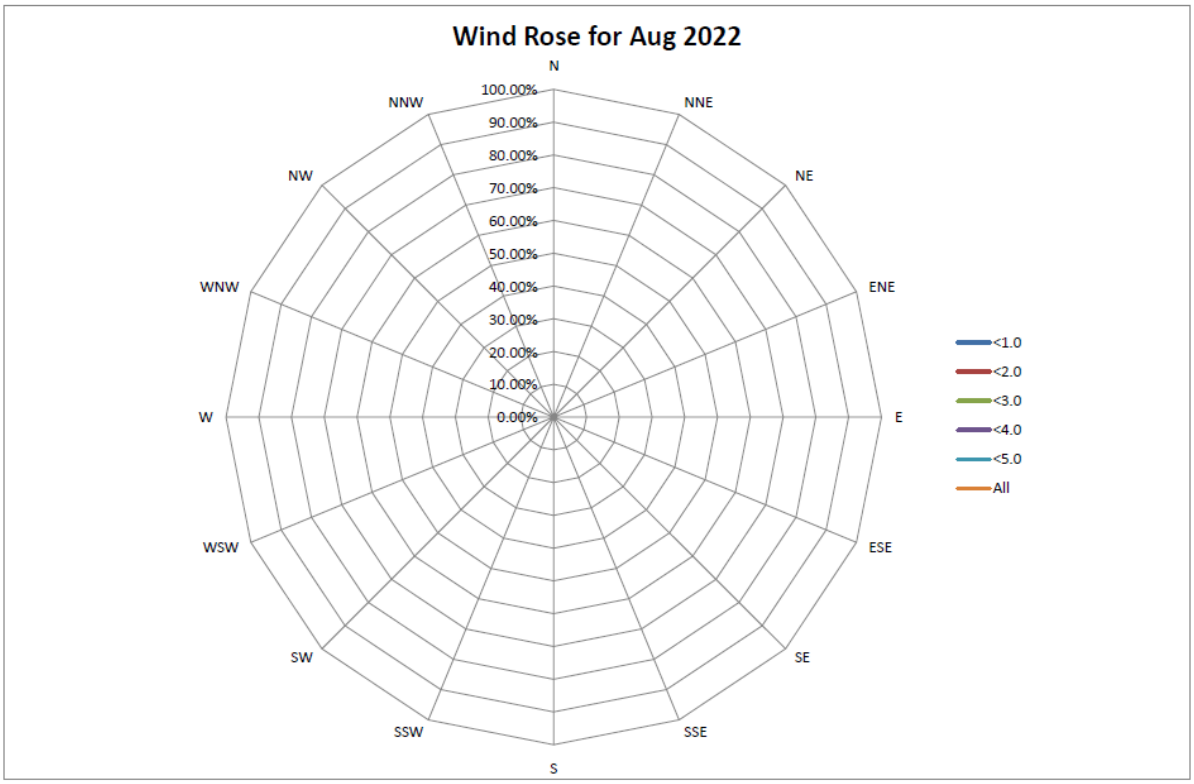
*Remark: Due to the Wind Speed Sensor has been disconnected on 4 Aug 2022, data loss in Aug 2022.

- Data from 5 Aug 2022 to 31 Aug 2022 is pending from Hong Kong Observatory and to be supplemented in subsequent version.
