South East New Territories (SENT) Landfill Extension

Quarterly Environmental Monitoring & Audit Report No.8

January 2021

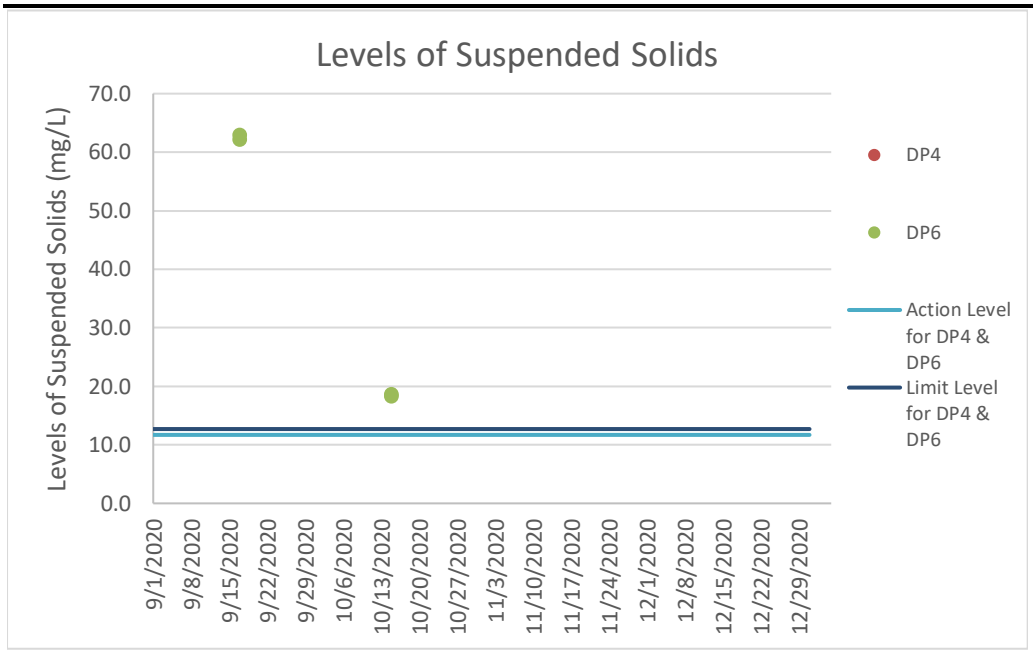
Figure F1.3 Graphical Presentation for Surface Water Quality Monitoring (SS)

Based on the investigation conducted for the monitoring event with potential Action and Limit Levels exceedance with the Contractor, and the IEC, the SS exceedance at DP6 on 15 October 2020 was found deemed to Project-related activities.
