South East New Territories (SENT) Landfill Extension

Monthly Environmental Monitoring & Audit Report No.10 for October 2019

November 2019

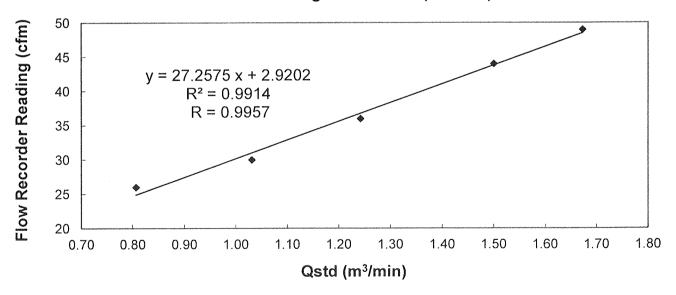
Sampler 9795 Calibration Curve Site: Tseung Kwan O 137 (TKO-A1)

Acceptance Criteria: Correlation coefficient (r) of the calibration curve greater than 0.990 after a 5-point calibration

The high volume sampler complies* / does not comply* with the specified requirements and is deemed acceptable*/ unacceptable* for use.

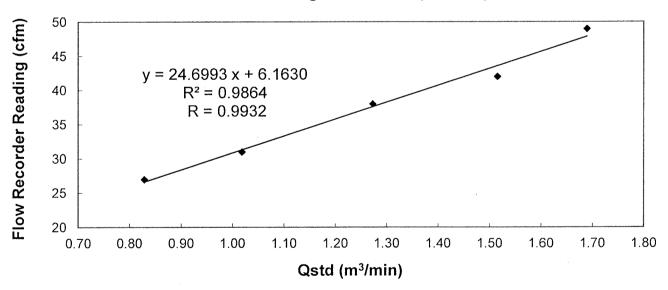
Sampler 9795 Calibration Curve Site: Tseung Kwan O 137 (TKO-A1)

Acceptance Criteria: Correlation coefficient (r) of the calibration curve greater than 0.990 after a 5-point calibration

The high volume sampler complies* / does not comply* with the specified requirements and is deemed acceptable*/ unacceptable* for use.

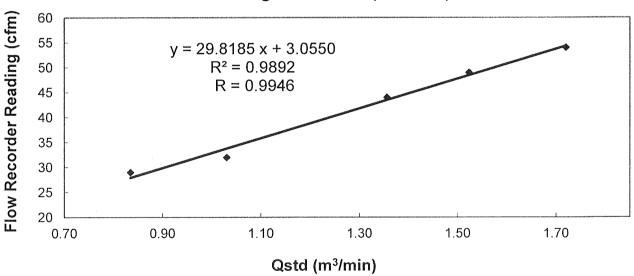
Sampler 1176 Calibration Curve Site: Tseung Kwan O 137 (TKO-A2a)

Acceptance Criteria: Correlation coefficient (r) of the calibration curve greater than 0.990 after a 5-point calibration

The high volume sampler complies* / does not comply* with the specified requirements and is deemed acceptable* / unacceptable * for use.

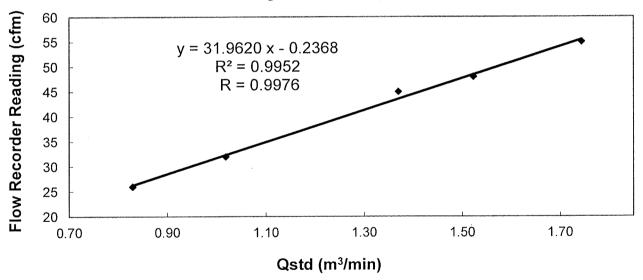
Sampler 1176 Calibration Curve Site: Tseung Kwan O 137 (TKO-A2a)

Acceptance Criteria: Correlation coefficient (r) of the calibration curve greater than 0.990 after a 5-point calibration

The high volume sampler complies* / does not comply* with the specified requirements and is deemed acceptable* / unacceptable * for use.

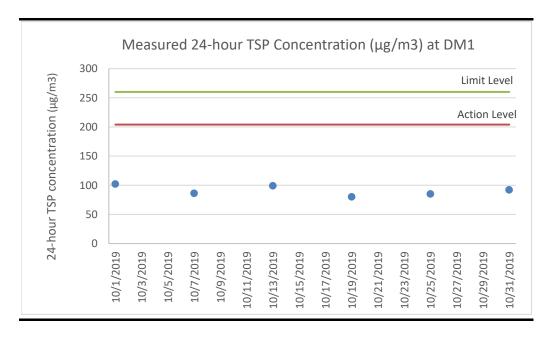
Figure D2.1 Graphical Presentation for 24-hr TSP Monitoring at DM1

DM1 corresponds to the existing TSP monitoring station TKO-A1 currently operating by CEDD.

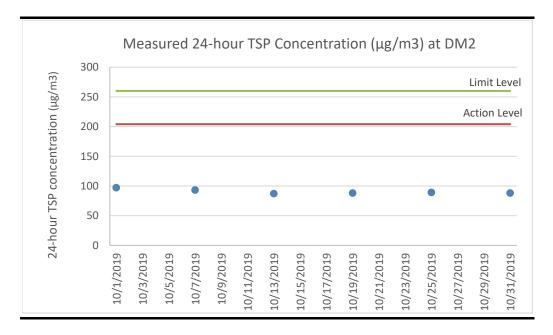
Figure D2.2 Graphical Presentation for 24-hr TSP Monitoring at DM2

$\ensuremath{\mathsf{DM2}}$ corresponds to the existing TSP monitoring station TKO-A2a currently operating by CEDD.
