South East New Territories (SENT) Landfill Extension

**Monthly Environmental Monitoring & Audit Report No.51
for March 2023**

April 2023

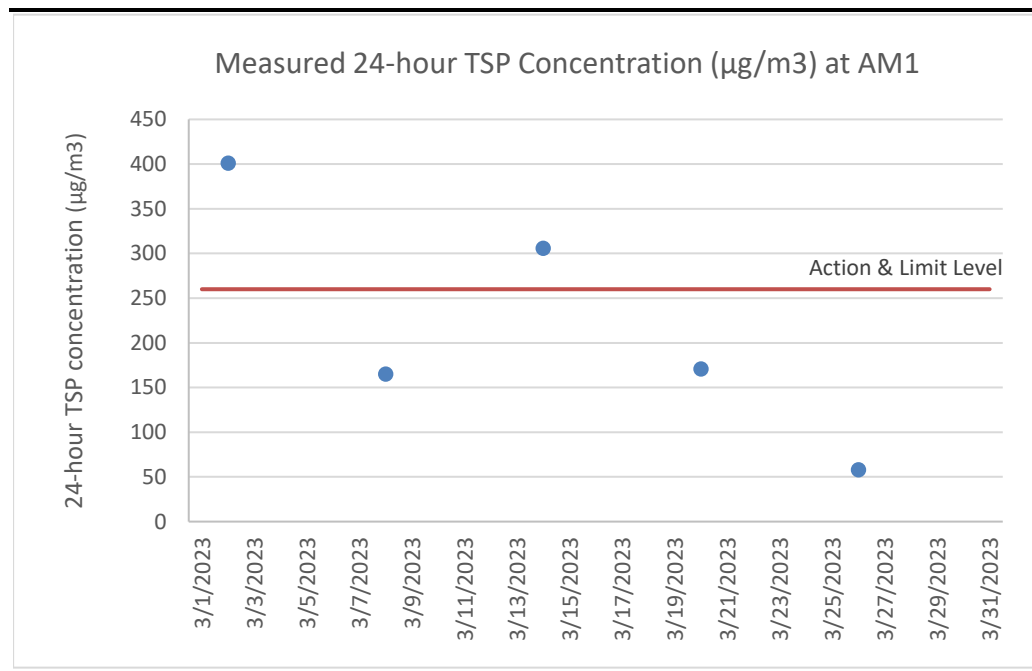
Start Date	Start Time	Finish Date	Finish Time	Weather	24-hour TSP ($\mu\text{g}/\text{m}^3$)
2 Mar 23	8:00	3 Mar 23	7:58	Sunny	401
8 Mar 23	8:00	9 Mar 23	8:02	Sunny	165
14 Mar 23	8:00	15 Mar 23	7:46	Cloudy	306
20 Mar 23	8:00	21 Mar 23	7:46	Cloudy	171
26 Mar 23	8:00	27 Mar 23	8:17	Rainy	58
Average					220
Min					58
Max					401

Figure D2.1 Graphical Presentation for 24-hr TSP Monitoring at AM1

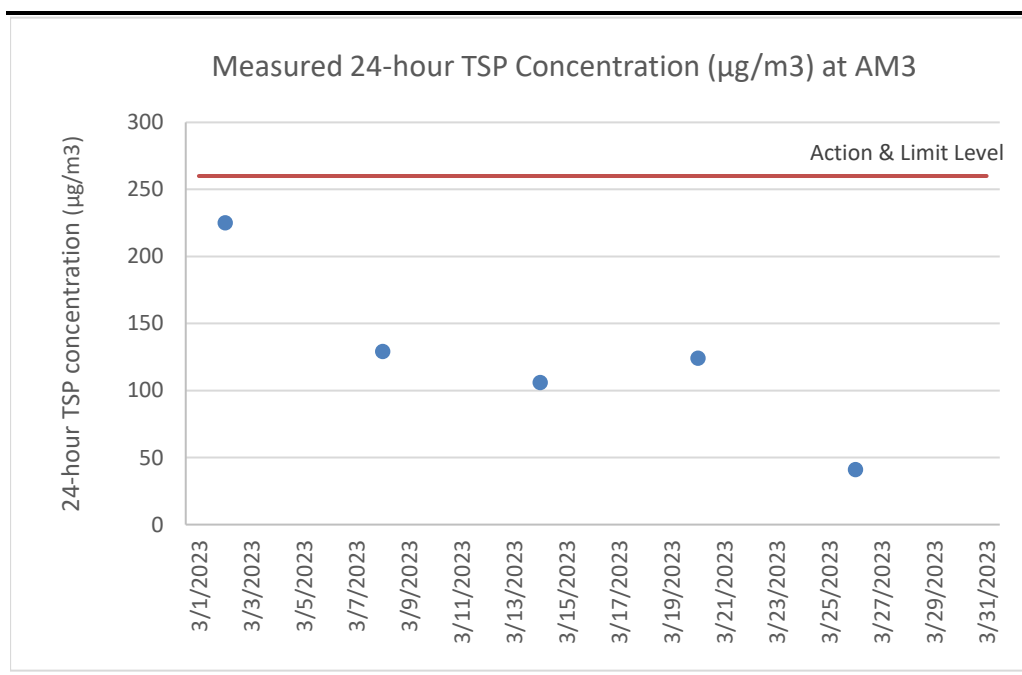
Start Date	Start Time	Finish Date	Finish Time	Weather	24-hour TSP ($\mu\text{g}/\text{m}^3$)
2 Mar 23	8:00	3 Mar 23	8:05	Sunny	225
8 Mar 23	8:00	9 Mar 23	8:04	Sunny	129
14 Mar 23	8:00	15 Mar 23	7:50	Cloudy	106
20 Mar 23	8:00	21 Mar 23	8:02	Cloudy	124
26 Mar 23	8:00	27 Mar 23	8:07	Rainy	41
Average					125
Min					41
Max					225

Figure D2.3 Graphical Presentation for 24-hr TSP Monitoring at AM3

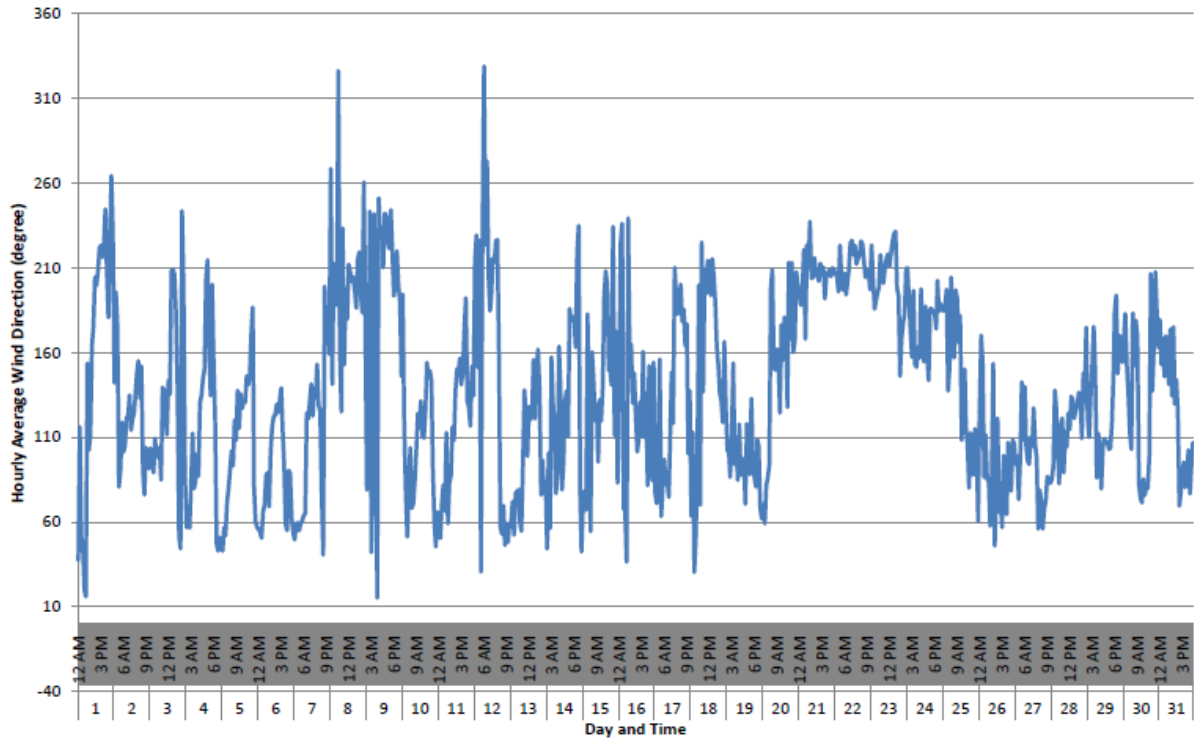
Hourly Average Wind Direction (degree) for March 2023

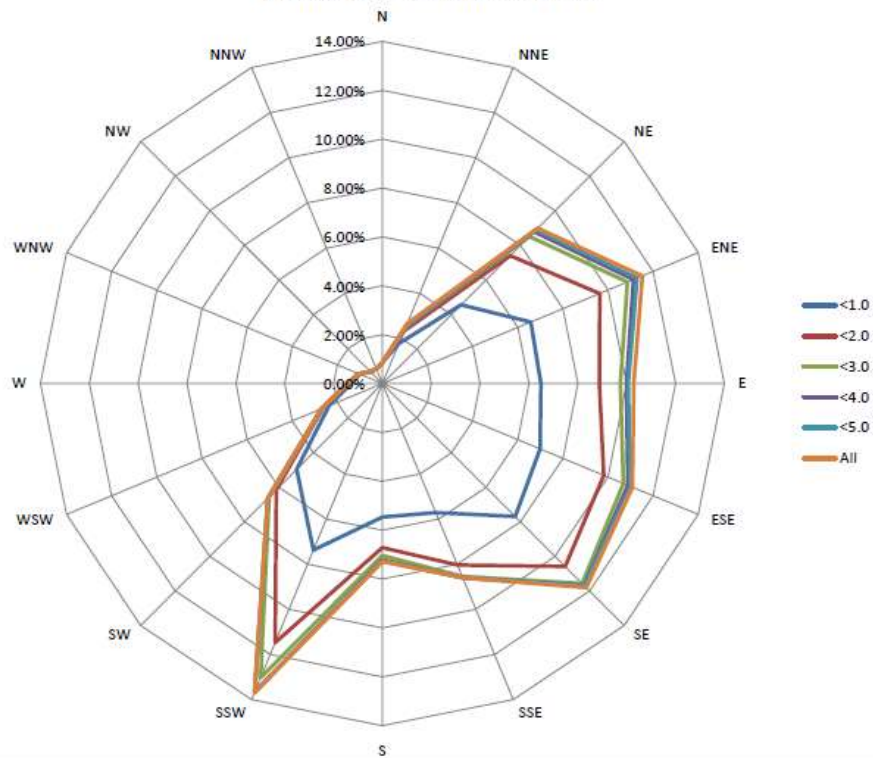
Wind Rose for March 2023

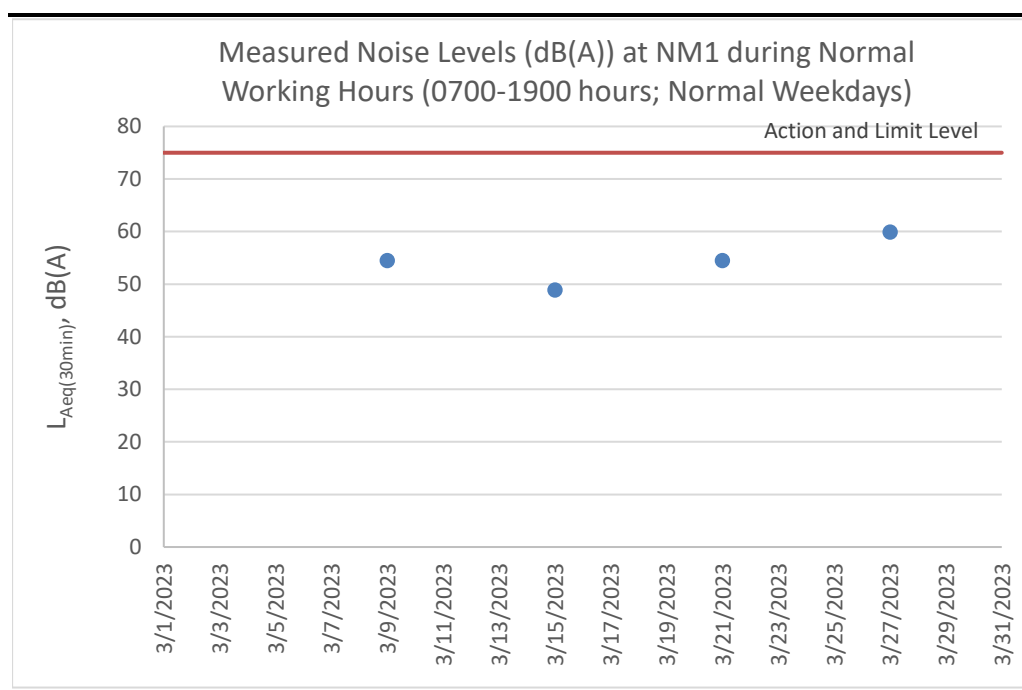
Date	Start Time	Finish Time	Weather	L10 (30min)	L90 (30min)	Leq (30min)
9 Mar 23	14:33	15:03	Sunny	56.5	51.7	54.5
15 Mar 23	9:28	9:58	Sunny	50.6	46.5	48.9
21 Mar 23	9:31	10:01	Cloudy	56.0	52.5	54.5
27 Mar 23	9:52	10:22	Cloudy	52.9	48.3	59.9
Average						54.5
Min						48.9
Max						59.9

Figure E2.1 Graphical Presentation for Noise Monitoring at NM1
