South East New Territories (SENT) Landfill Extension

Monthly Environmental Monitoring & Audit Report No.54
for June 2023

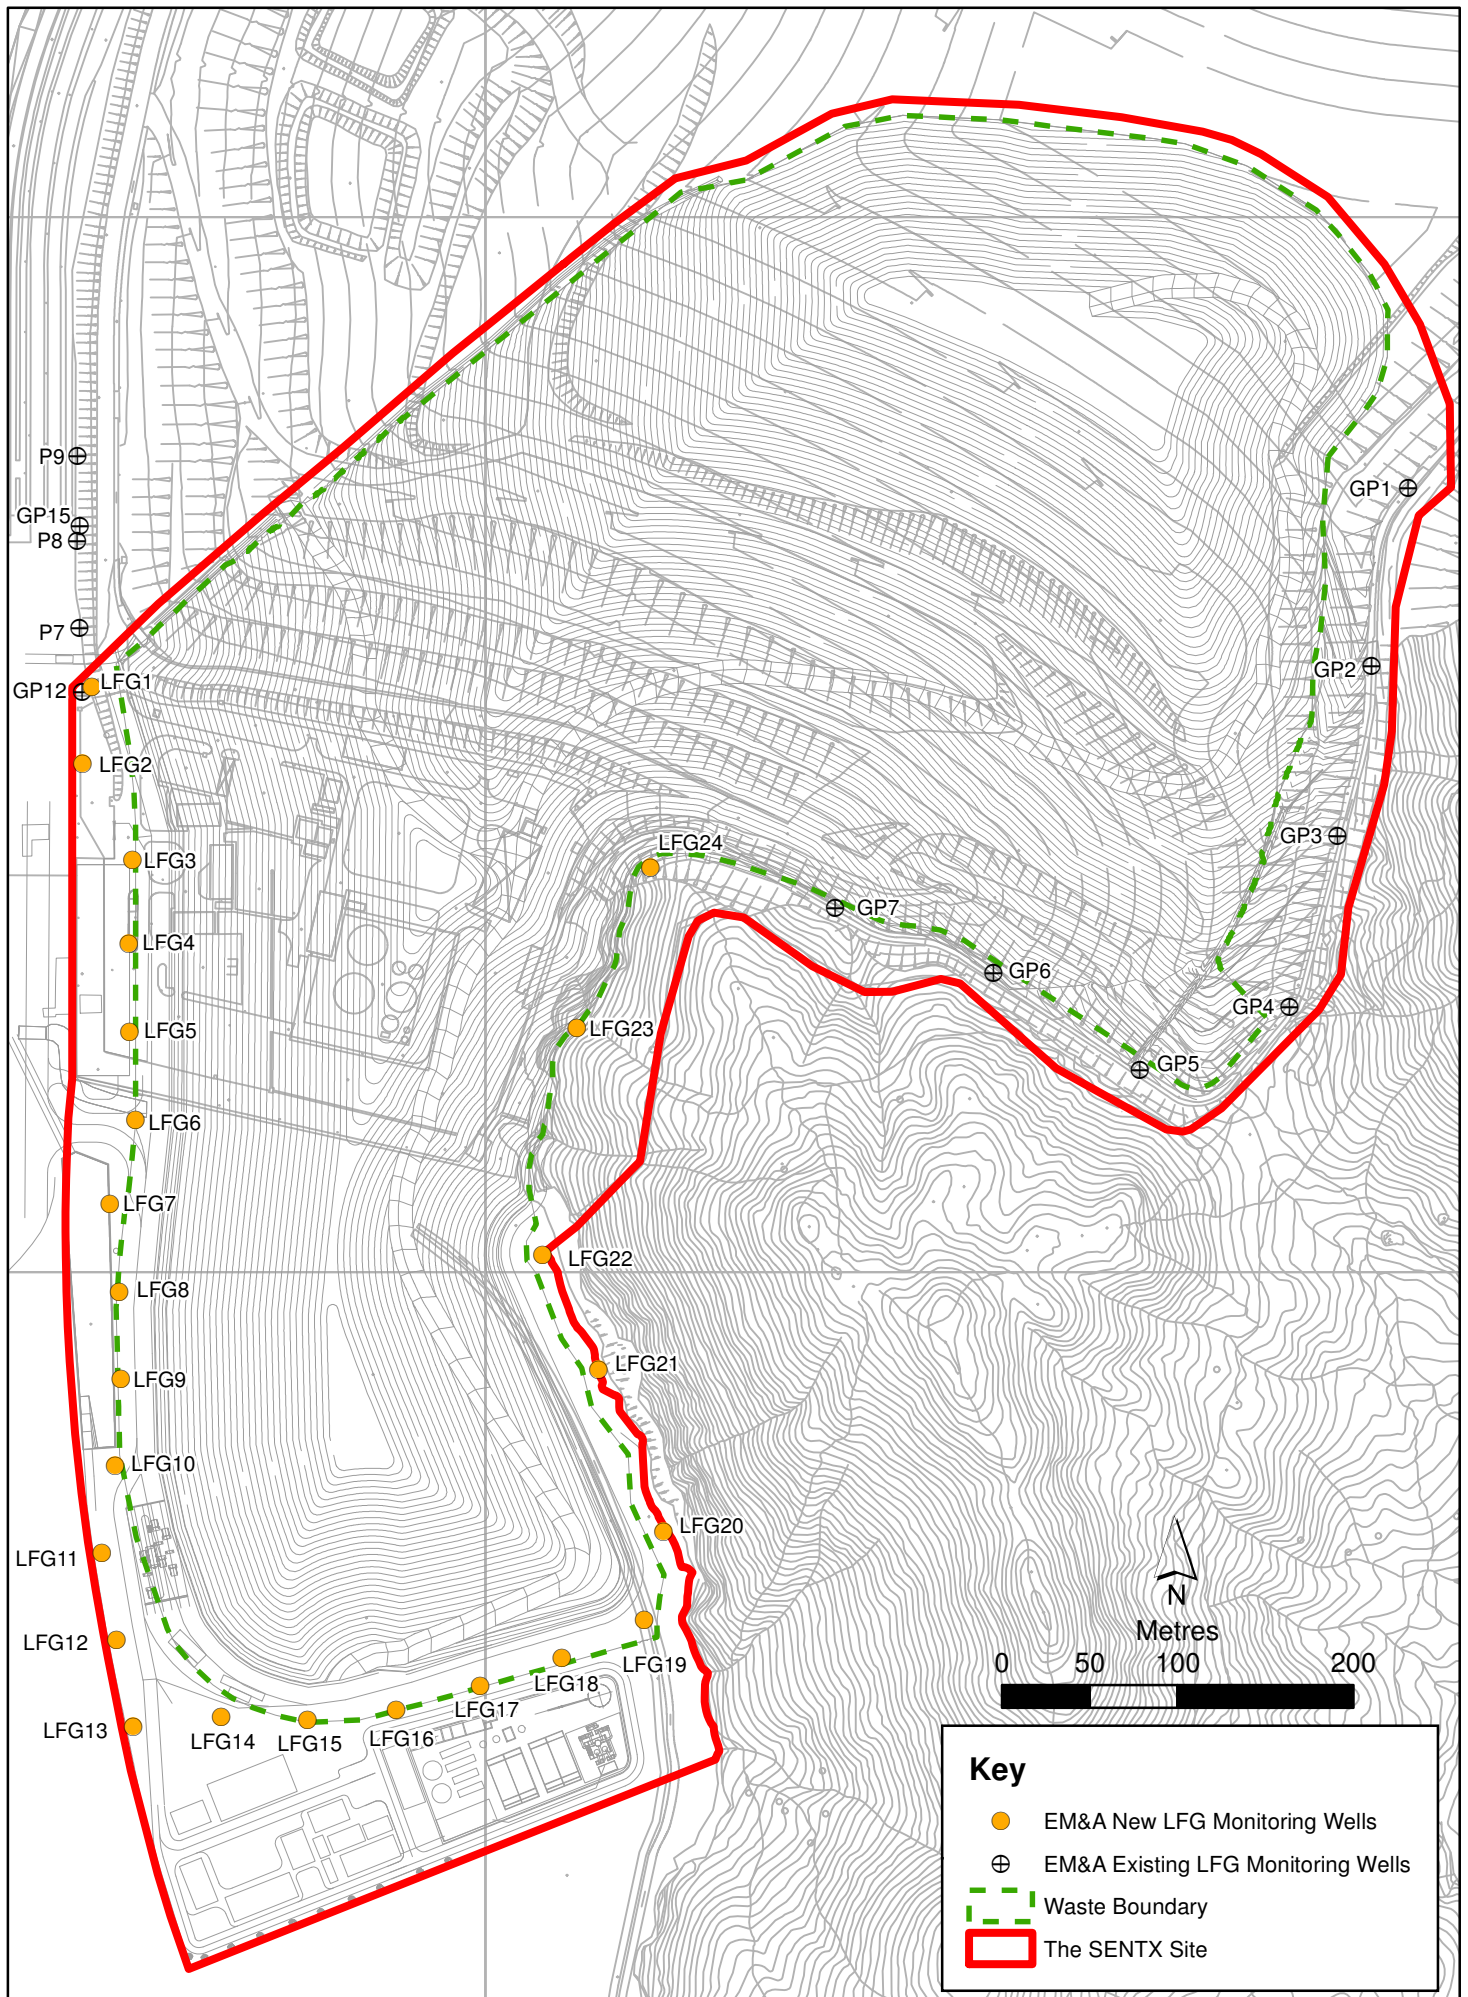
Figure 2.3

Location of Landfill Gas Monitoring Wells

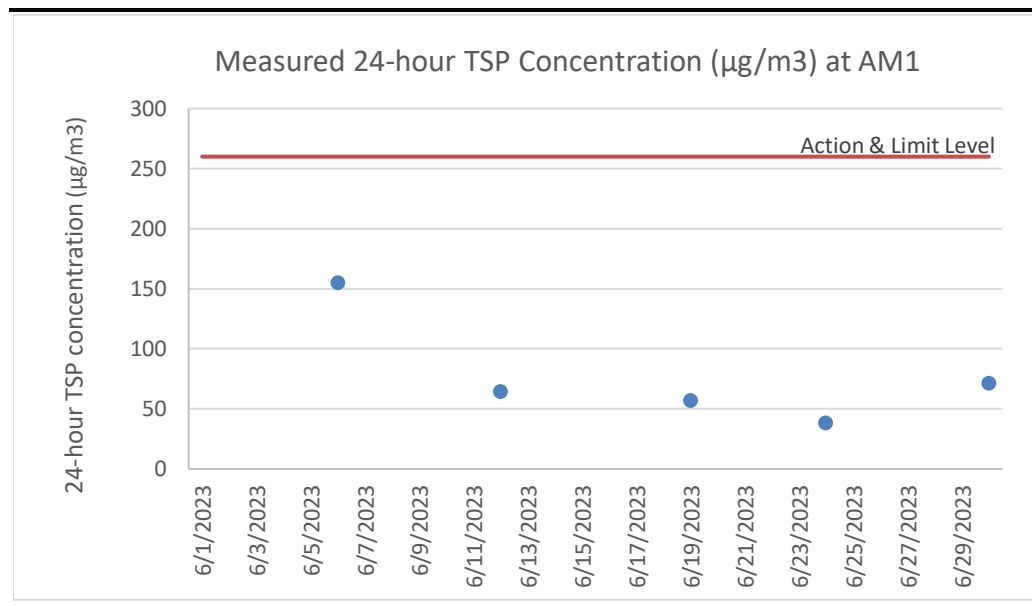
Start Date	Start Time	Finish Date	Finish Time	Weather	24-hour TSP ($\mu\text{g}/\text{m}^3$)
6 Jun 23	8:00	7 Jun 23	8:00	Cloudy	155
12 Jun 23	8:00	13 Jun 23	8:00	Cloudy	64
19 Jun 23	8:00	20 Jun 23	8:00	Fine	57
24 Jun 23	8:00	25 Jun 23	8:00	Cloudy	38
30 Jun 23	8:00	1 Jul 23	8:00	Fine	71
Average					77
Min					38
Max					155

Figure D2.1 Graphical Presentation for 24-hr TSP Monitoring at AM1

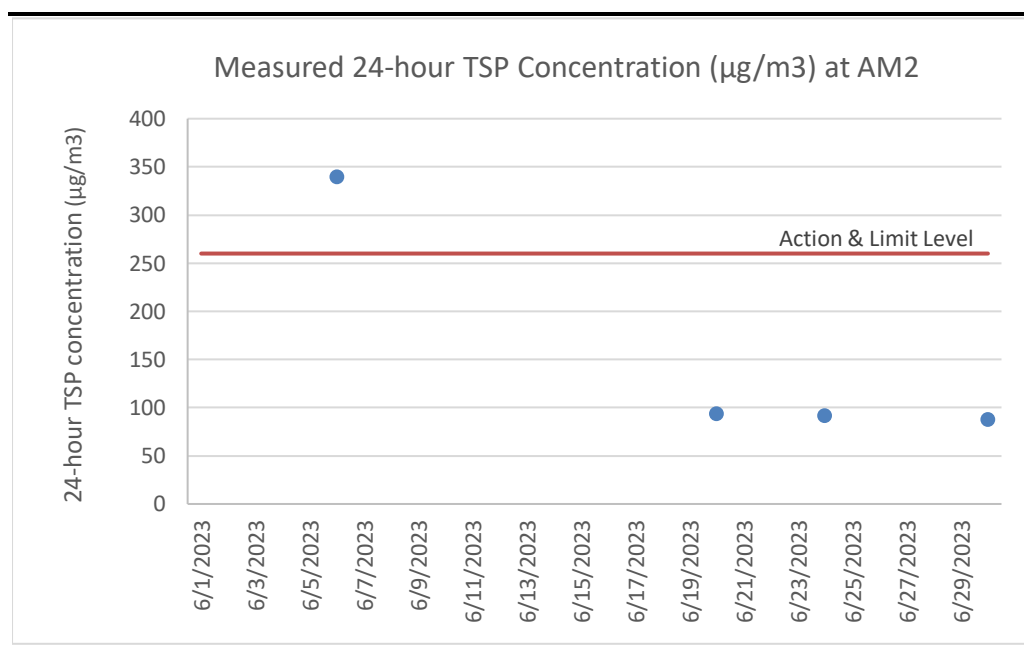
Start Date	Start Time	Finish Date	Finish Time	Weather	24-hour TSP ($\mu\text{g}/\text{m}^3$)
6 Jun 23	8:00	7 Jun 23	8:00	Cloudy	340
12 Jun 23	8:00	13 Jun 23	8:00	Cloudy	Discarded due to abnormal condition of the filter paper
20 Jun 23	8:00	21 Jun 23	8:00	Fine	94
24 Jun 23	8:00	25 Jun 23	8:00	Cloudy	92
30 Jun 23	8:00	1 Jul 23	8:00	Fine	88
				Average	154
				Min	88
				Max	340

Figure D2.2 Graphical Presentation for 24-hr TSP Monitoring at AM2

The TSP monitoring results at AM2 on 12 June and 18 June 2023 were discarded due to the abnormally wet condition of the filter paper (suspected to be under the influence of sprinkler operation and adverse weather condition). Repeat measurement at AM2 was arranged on 20 June 2023.

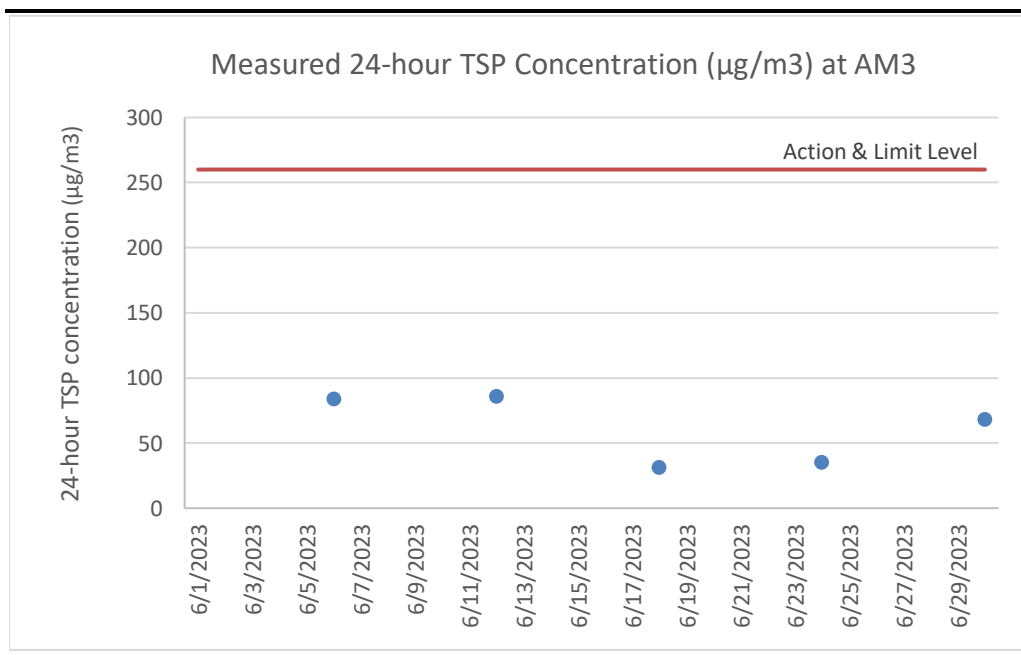
Start Date	Start Time	Finish Date	Finish Time	Weather	24-hour TSP ($\mu\text{g}/\text{m}^3$)
6 Jun 23	8:00	7 Jun 23	8:00	Cloudy	84
12 Jun 23	8:00	13 Jun 23	8:00	Cloudy	86
18 Jun 23	8:00	19 Jun 23	8:00	Fine	31
24 Jun 23	8:00	25 Jun 23	8:00	Cloudy	35
30 Jun 23	8:00	1 Jul 23	8:00	Fine	68
Average					61
Min					31
Max					86

Figure D2.3 Graphical Presentation for 24-hr TSP Monitoring at AM3

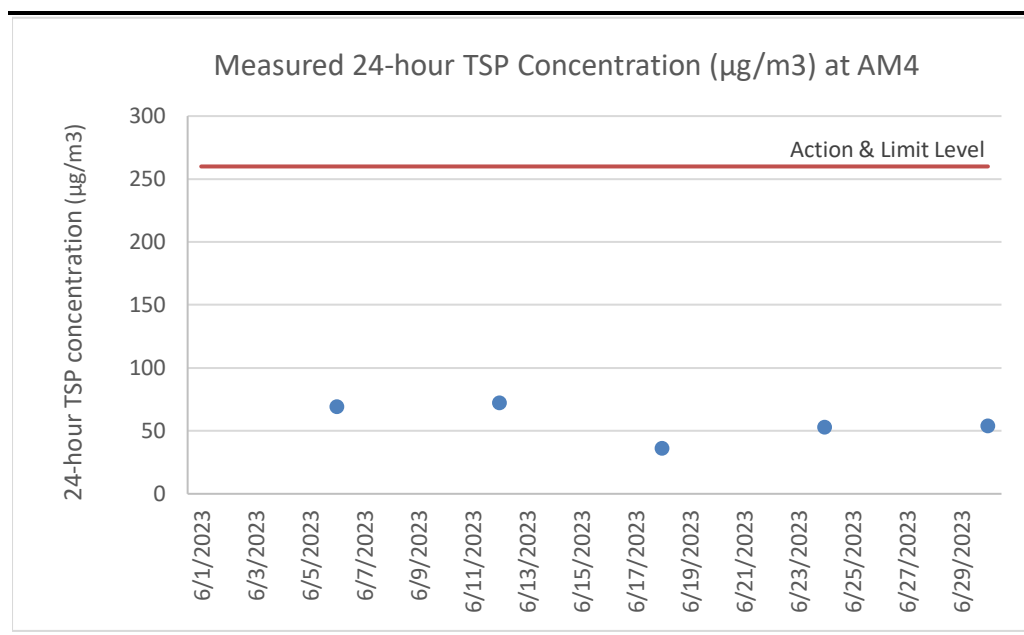
Start Date	Start Time	Finish Date	Finish Time	Weather	24-hour TSP ($\mu\text{g}/\text{m}^3$)
6 Jun 23	8:00	7 Jun 23	8:00	Cloudy	69
12 Jun 23	8:00	13 Jun 23	8:00	Cloudy	72
18 Jun 23	8:00	19 Jun 23	8:00	Fine	36
24 Jun 23	8:00	25 Jun 23	8:00	Cloudy	53
30 Jun 23	8:00	1 Jul 23	8:00	Fine	54
Average					57
Min					36
Max					72

Figure D2.4 Graphical Presentation for 24-hr TSP Monitoring at AM4

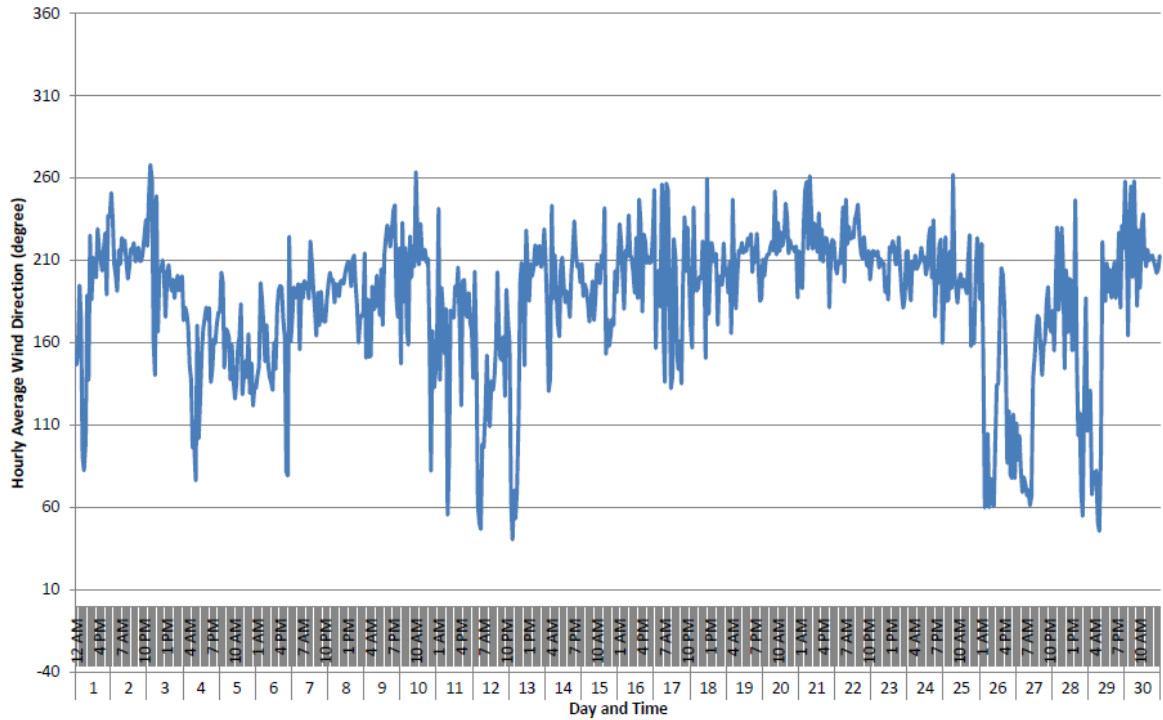
Hourly Average Wind Direction (degree) for June 2023

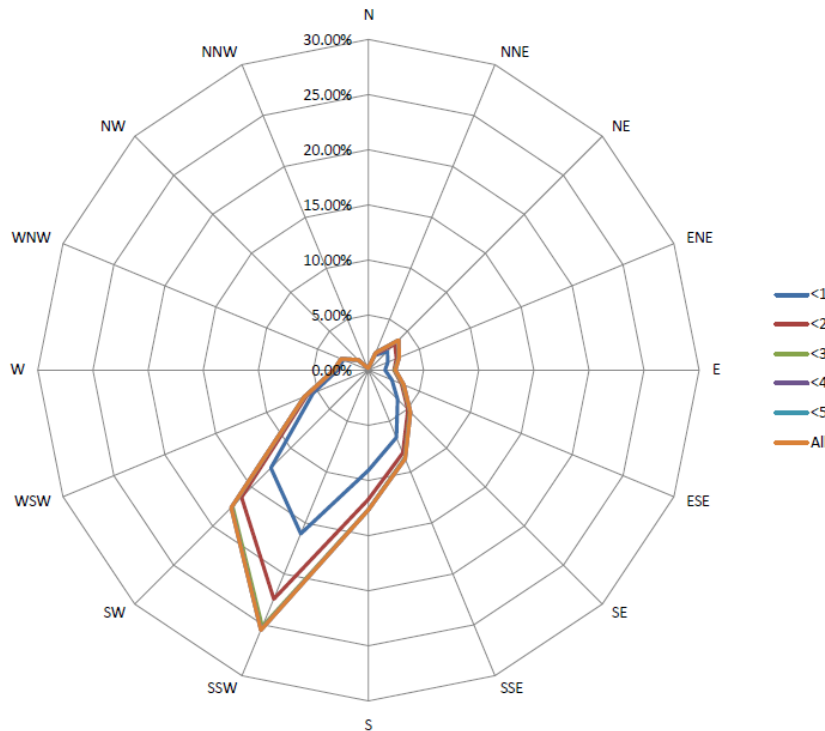
Wind Rose for June 2023

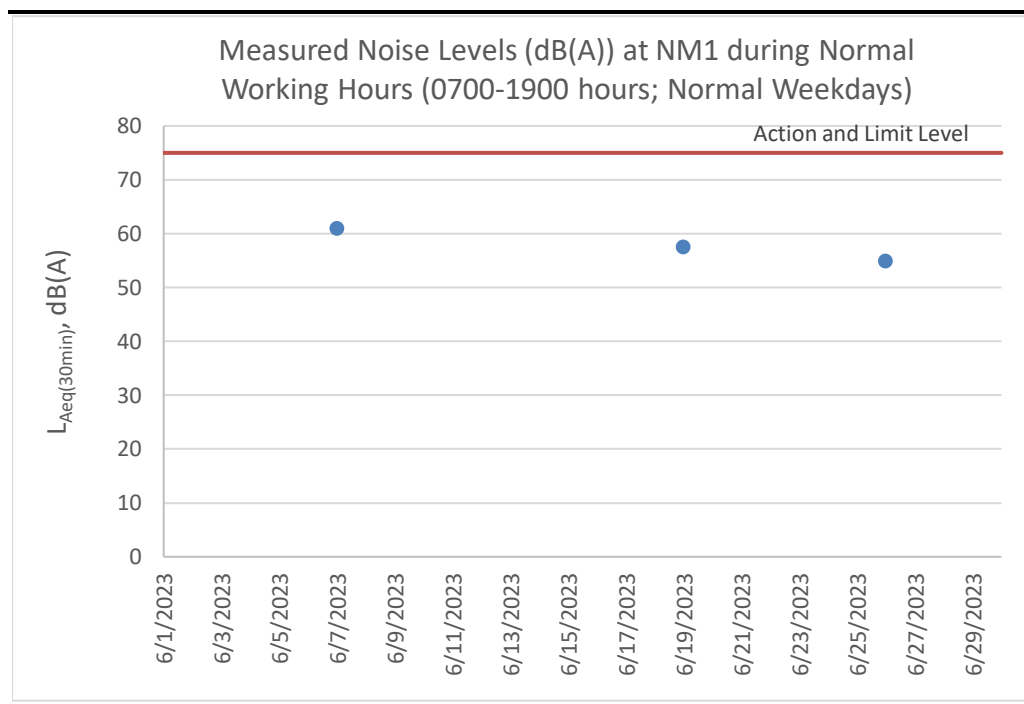
Date	Start Time	Finish Time	Weather	L ₁₀ (30min)	L ₉₀ (30min)	L _{eq} (30min)
7 Jun 23	10:15	10:45	Sunny	61.9	59.9	61.0
13 Jun 23	10:45	11:15	Rainy	Monitoring was cancelled due to adverse weather.		
19 Jun 23	11:00	11:30	Sunny	59.5	53.1	57.6
26 Jun 23	10:35	11:05	Sunny	57.3	51.3	54.9
						Average 57.8
						Min 54.9
						Max 61.0

Figure E2.1 Graphical Presentation for Noise Monitoring at NM1
