## South East New Territories (SENT) Landfill Extension

Monthly Environmental Monitoring & Audit Report No.57  
for September 2023

## Monthly Environmental Monitoring & Audit Report for September 2023

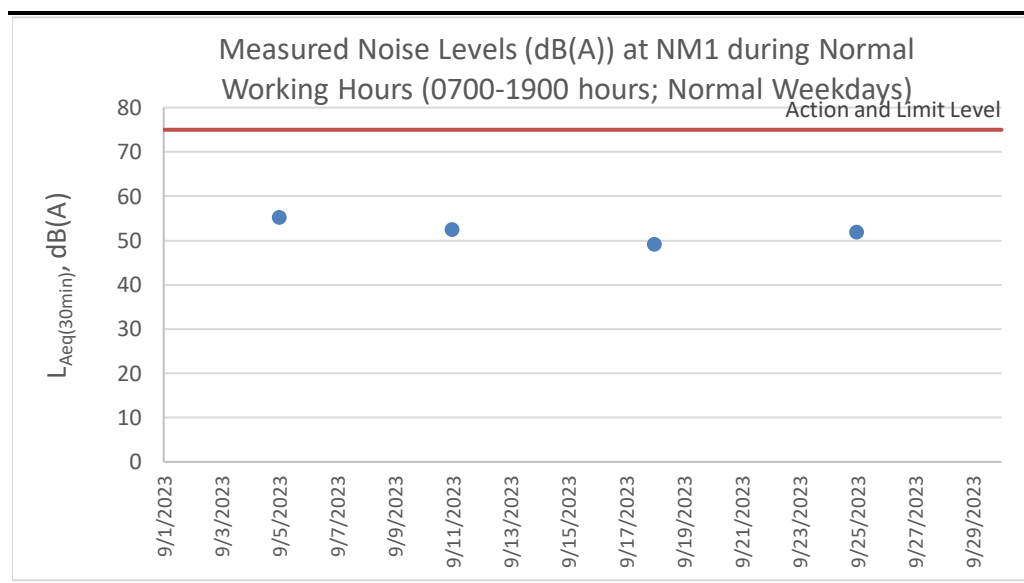
Date	Start Time	Finish Time	Weather	L <sub>10</sub> (30min)	L <sub>90</sub> (30min)	L <sub>eq</sub> (30min)
5 Sep 23	14:27	14:57	Cloudy	56.5	53.4	55.2
11 Sep 23	10:40	11:10	Cloudy	54.0	49.3	52.5
18 Sep 23	10:11	10:41	Sunny	50.9	46.4	49.1
25 Sep 23	10:41	11:11	Sunny	53.6	48.0	51.9
<b>Average</b>						52.2
<b>Min</b>						49.1
<b>Max</b>						55.2

**Figure E2.1 Graphical Presentation for Noise Monitoring at NM1**
