# South East New Territories (SENT) Landfill Extension

Monthly Environmental Monitoring & Audit Report No.63 for March 2024

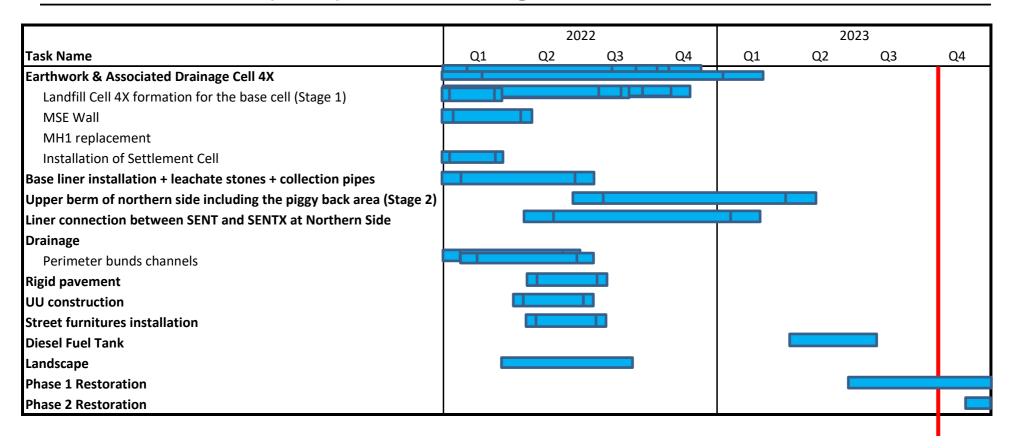
# SENT Landfill Extension (SENTX) - Construction Programme for Cell 4X Updat

20	)23					
Task Name	Q1	Q2	Q3	Q4	Q1	Q2	Q3	Q4
Phase 1 Restoration								
Subgrade soil + Liner								
Cover Soil								
Above Cap Gas pipe + Drainage				1				
Landscape								
Phase 2 Restoration								
Subgrade soil + Liner								
Cover Soil								
Above Cap Gas pipe + Drainage								
Landscape

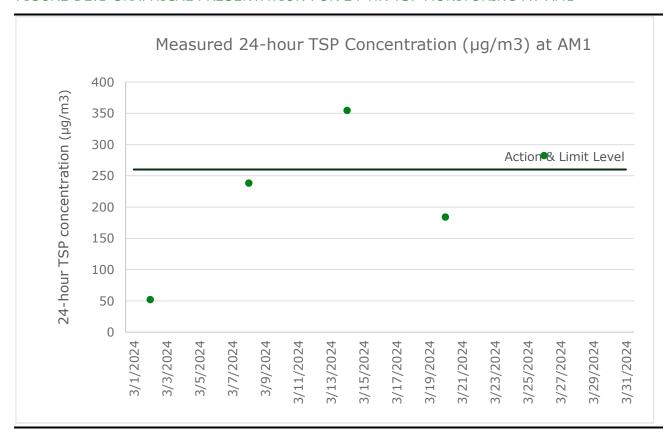
FIGURE D2.1 GRAPHICAL PRESENTATION FOR 24-HR TSP MONITORING AT AM1

Start Date	Start Time	Finish Date	Finish Time	Weather	24-hour TSP (μg/m³)				
2 Mar 24	8:00	3 Mar 24	8:00	Cloudy	52				
8 Mar 24	8:00	9 Mar 24	8:00	Cloudy	238				
14 Mar 24	8:00	15 Mar 24	8:00	Fine	354				
20 Mar 24	8:00	21 Mar 24	8:00	Sunny	184				
26 Mar 24	8:00	27 Mar 24	8:00	Fine	282				
		·		Average	222				
	52								
		Мах

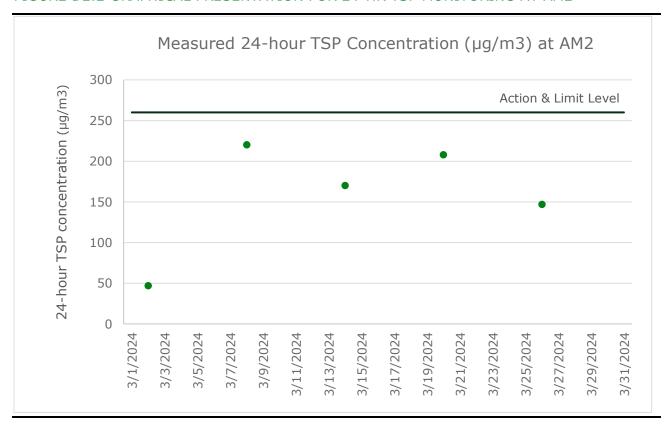
FIGURE D2.2 GRAPHICAL PRESENTATION FOR 24-HR TSP MONITORING AT AM2

Start Date	Start Time	Finish Date	Finish Time	Weather	24-hour TSP (μg/m³)
2 Mar 24	8:00	3 Mar 24	8:00	Cloudy	47
8 Mar 24	8:00	9 Mar 24	8:00	Cloudy	220
14 Mar 24	8:00	15 Mar 24	8:00	Fine	170
20 Mar 24	8:00	21 Mar 24	8:00	Sunny	208
26 Mar 24	8:00	27 Mar 24	8:00	Fine	147
				Average	158
				Min	47
				Max	220

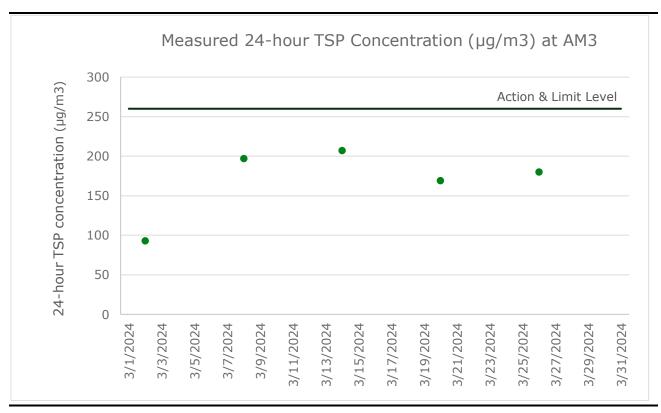
FIGURE D2.3 GRAPHICAL PRESENTATION FOR 24-HR TSP MONITORING AT AM3

Start Date	Start Time	Finish Date	Finish Time	Weather	24-hour TSP (μg/m³)
2 Mar 24	8:00	3 Mar 24	8:00	Cloudy	93
8 Mar 24	8:00	9 Mar 24	8:00	Cloudy	197
14 Mar 24	8:00	15 Mar 24	8:00	Fine	207
20 Mar 24	8:00	21 Mar 24	8:00	Sunny	169
26 Mar 24	8:00	27 Mar 24	8:00	Fine	180
				Average	169
				Min	93
	207

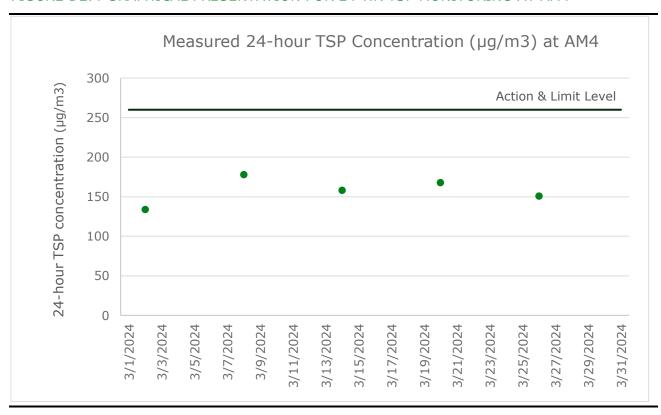
FIGURE D2.4 GRAPHICAL PRESENTATION FOR 24-HR TSP MONITORING AT AM4

Start Date	Start Time	Finish Date	Finish Time	Weather	24-hour TSP (μg/m³)			
2 Mar 24	8:00	3 Mar 24	8:00	Cloudy	134			
8 Mar 24	8:00	9 Mar 24	8:00	Cloudy	178			
14 Mar 24	8:00	15 Mar 24	8:00	Fine	158			
20 Mar 24	8:00	21 Mar 24	8:00	Sunny	168			
26 Mar 24	8:00	27 Mar 24	8:00	Fine	151			
				Average	158			
	Min							
	Max

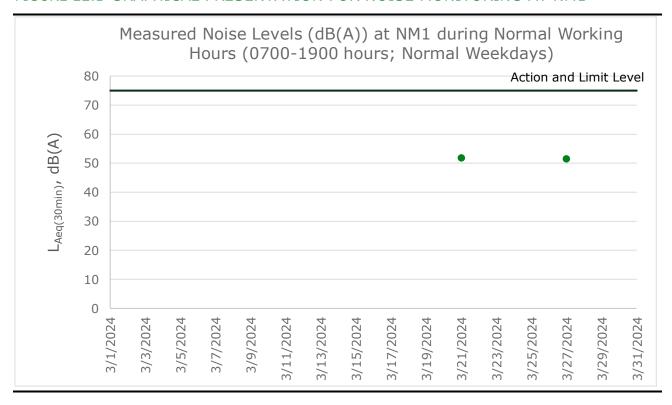
FIGURE E2.1 GRAPHICAL PRESENTATION FOR NOISE MONITORING AT NM1

Date	Start Time	Finish Time	Weather	L <sub>10 (30min)</sub>	L <sub>90 (30min)</sub>	L <sub>eq (30min)</sub>		
4 Mar 24	10:26	10:56	Rainy	Monitoring was cancelled due to adverse weather.				
11 Mar 24	10:32	11:02	Rainy	Monitoring was cancelled due to adverse weather.				
21 Mar 24	14:45	15:15	Sunny	53.9	49.0	51.9		
27 Mar 24	10:43	11:13	Cloudy	54.1	47.1	51.5		
					Average	51.7		
Min					51.5			
Max						51.9
