South East New Territories (SENT) Landfill Extension

Monthly Environmental Monitoring & Audit Report No.4
for April 2019

Monthly Environmental Monitoring & Audit Report for April 2019

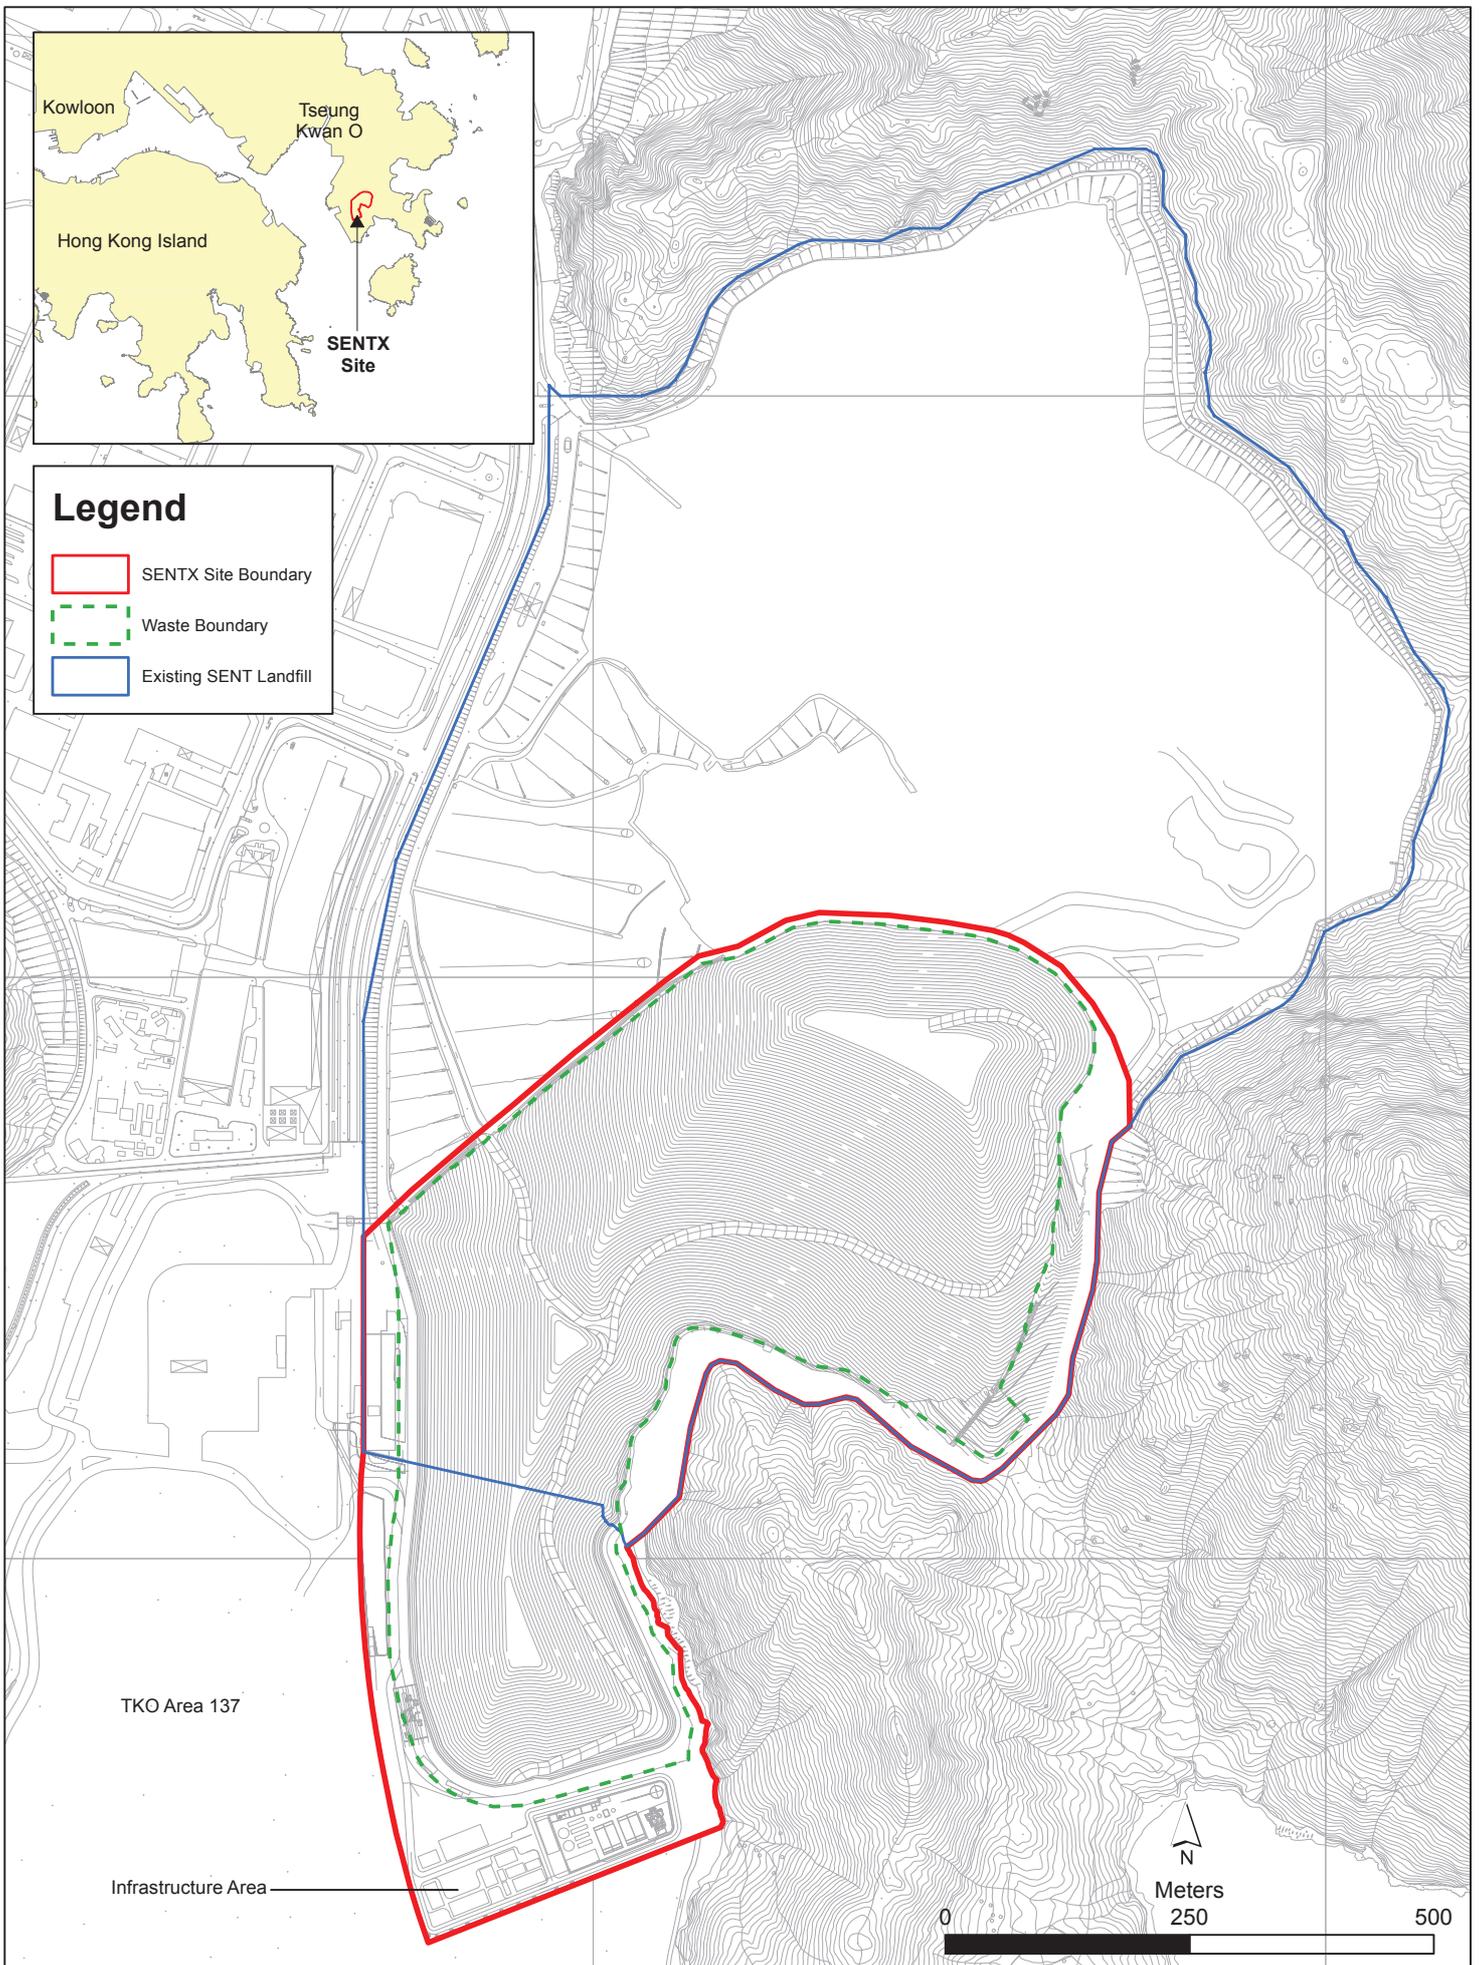
Figure 1.1

Layout Plan of SENTX

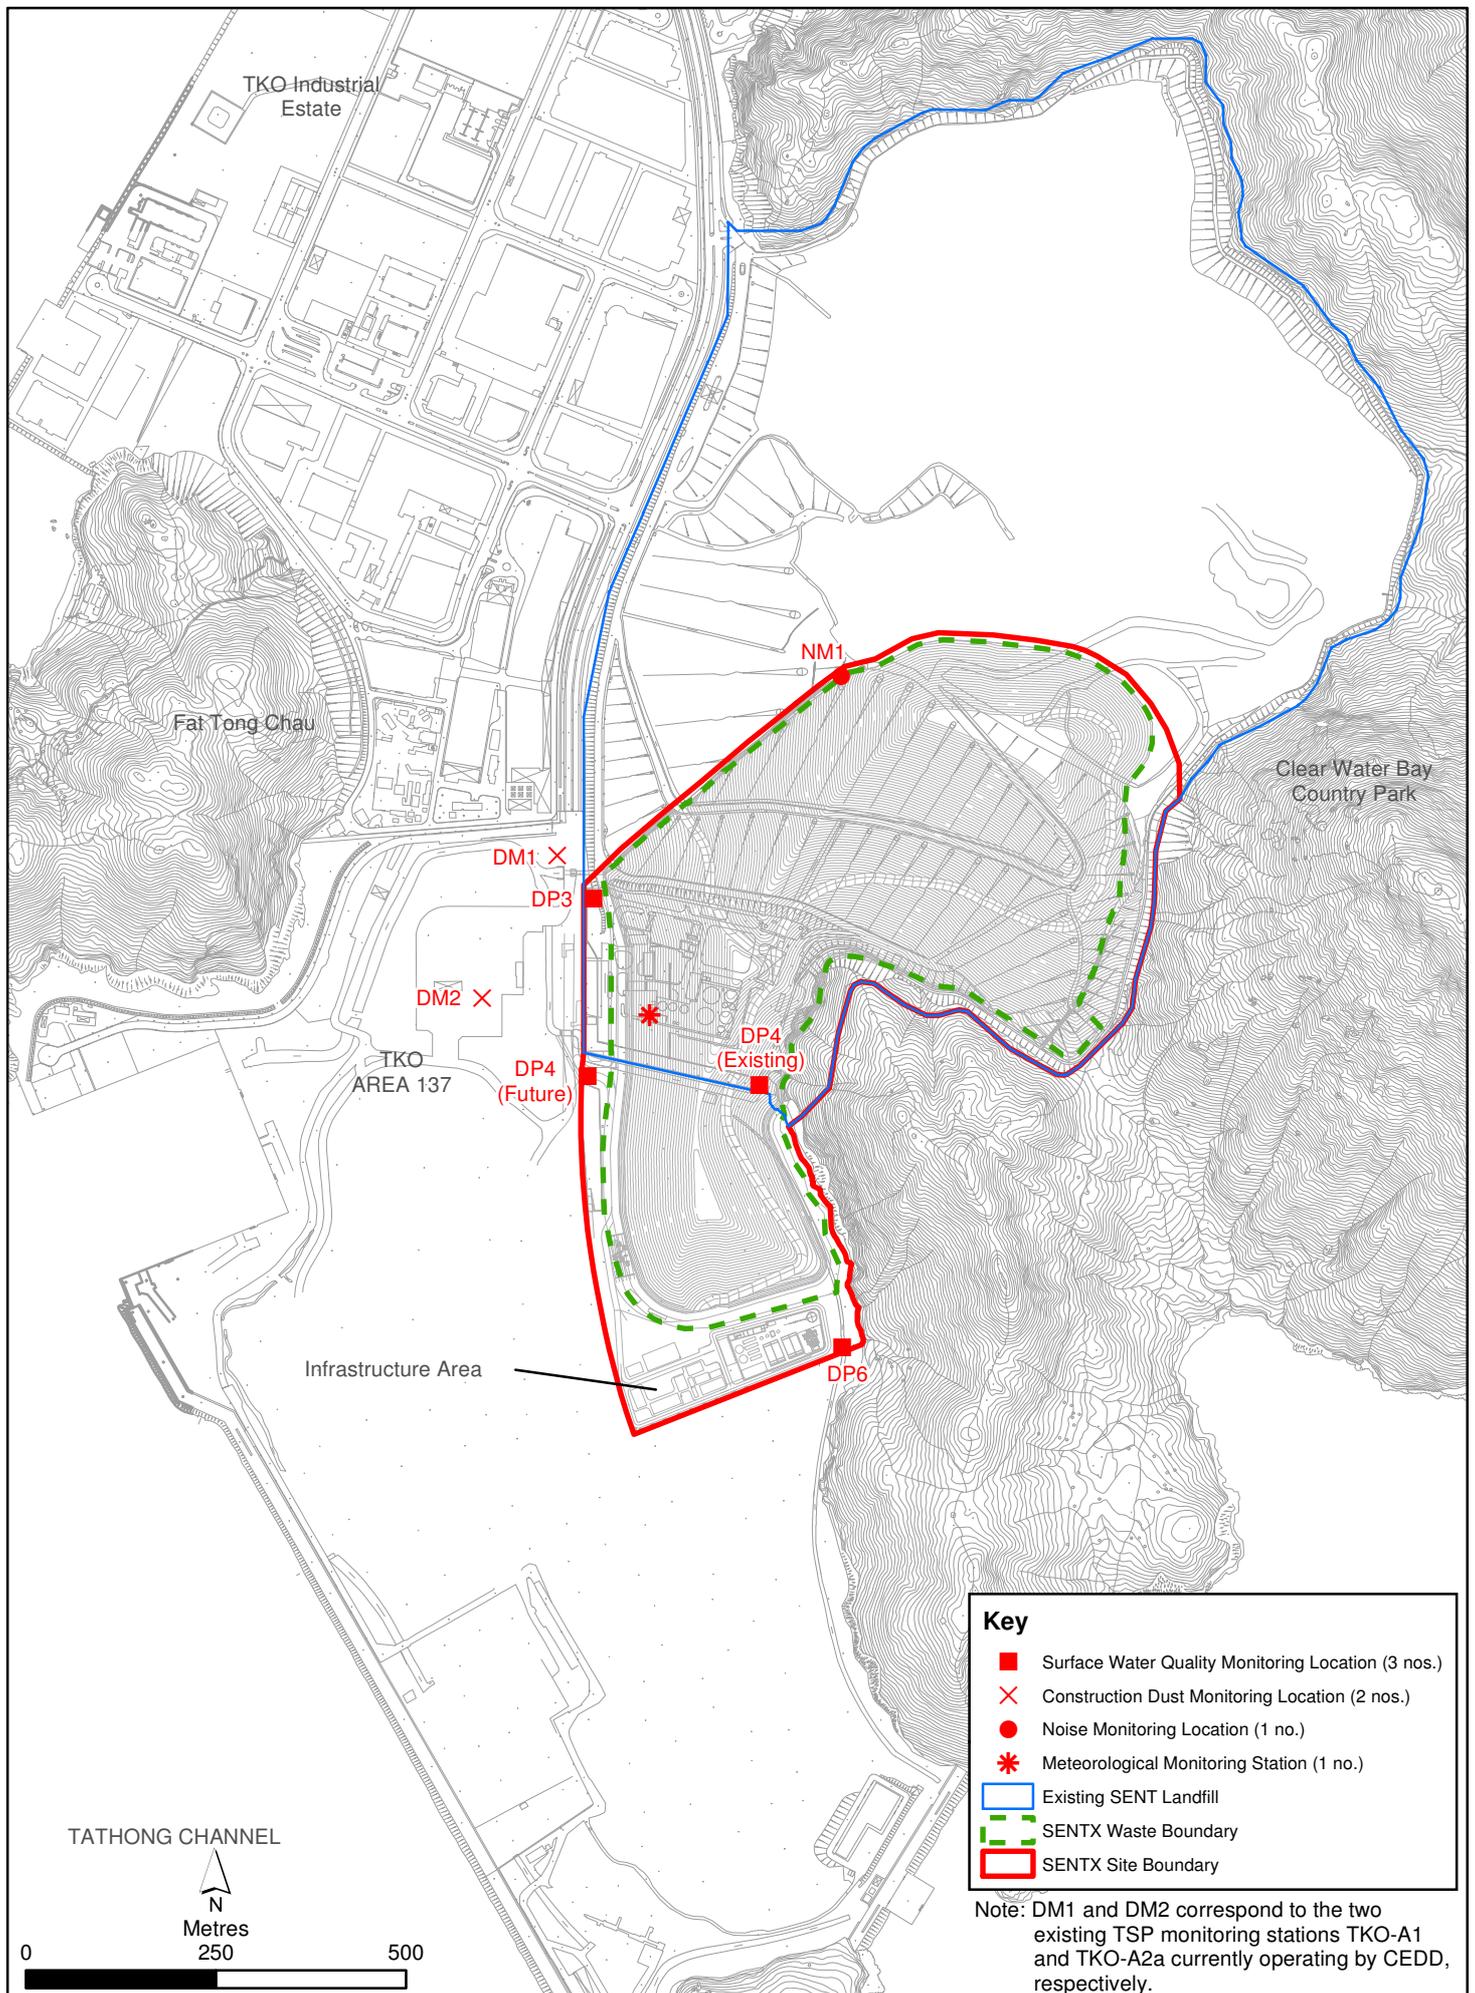
Figure 2.1

Environmental Impact Monitoring Locations
